Annex 5

A5-3 Documentation of damage cases

Table A5-3.1	Sultandağı, residential building	(SUL)
Table A5-3.2	İzmit, residential building	(IZT-1)
Table A5-3.3	İzmit, residential building	(IZT-2a)
Table A5-3.4	İzmit, residential building	(IZT-2b)
Table A5-3.5	İzmit, residential building	(IZT-2c)
Table A5-3.6	Düzce, residential building	(DUZ-1)
Table A5-3.7	Düzce, residential building	(DUZ-2)
Table A5-3.8	Seymen, residential building	(SEM)
Table A5-3.9	Sapanca, residential building	(SAC)
Table A5-3.10	Gölyaka, Yavuzlar Fındık	(YZL)
Table A5-3.11	Cumaná, Avenida Perimetral	(AVE)
Table A5-3.12	Cumaná, Edificio Miramar	(MIR)
Table A5-3.13	Cumaná, Edificio Residencial	(EDR)
Table A5-3.14	Cumaná, Edificio de oficinas Toyota	(TOY)

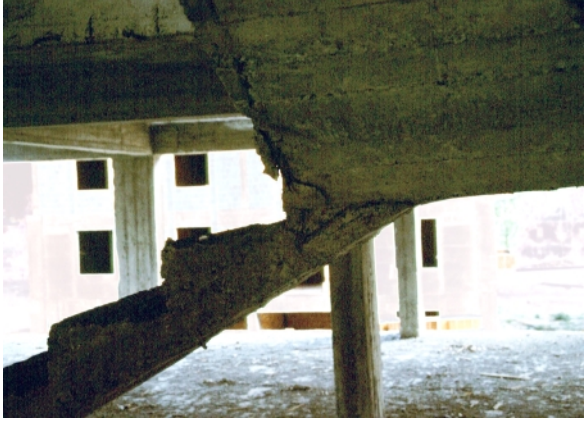
Table A5-3.1 (cont.)	Damage case: Sultandađı, residential building	SUL
<i>Structural type</i> 5-story RC-frame structure (building shell)		
<i>Structural damage</i> <ul style="list-style-type: none">- small cracks in columns and beams, especially at the ground story- damage to stair landings of ground and first upper story showing spalling of concrete covers and element displacements of few centimeters (cf. →)

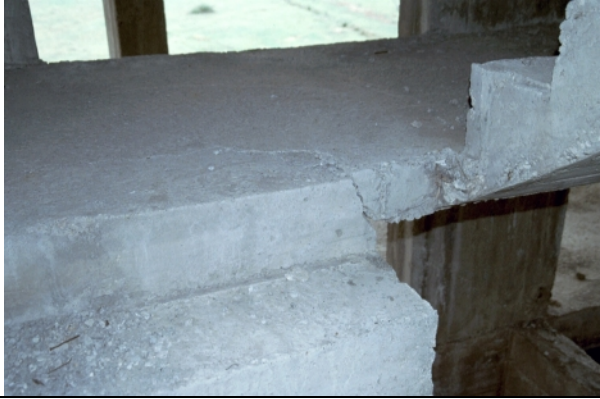
Table A5-3.2 (cont.)	Damage case: İzmit, residential building	IZT-1
<i>Structural type</i> 7-story RC-frame structure (building shell)		
<i>Extent of structural damage</i> <ul style="list-style-type: none">- small cracks in columns and beams, especially at the lower stories- damage to stair landings even at higher floors showing a few spalling of concrete covers (cf. →)

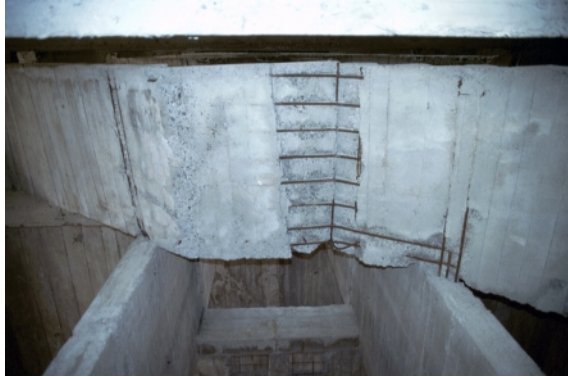
<p data-bbox="225 1294 826 1323">Damage to stair landings of ground floor (bottom view)</p> </div> <div data-bbox="858 472 1428 846" style="text-align: center;">

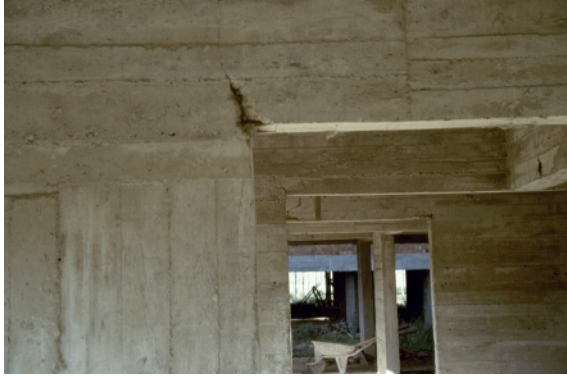
<p data-bbox="874 860 1414 889">Large crack at beam-column joint at ground floor</p> </div> <div data-bbox="858 904 1428 1279" style="text-align: center;">

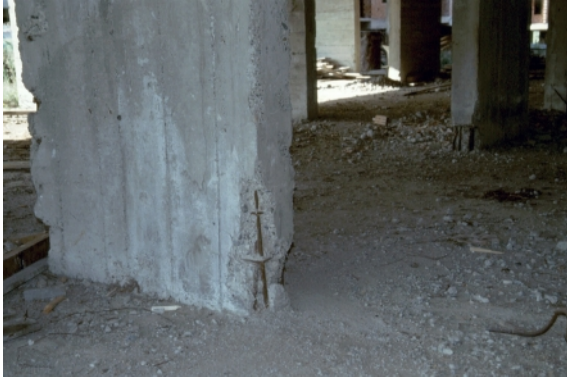
<p data-bbox="874 1294 1414 1323">Spalling of concrete cover at ground floor column</p> </div> </div>

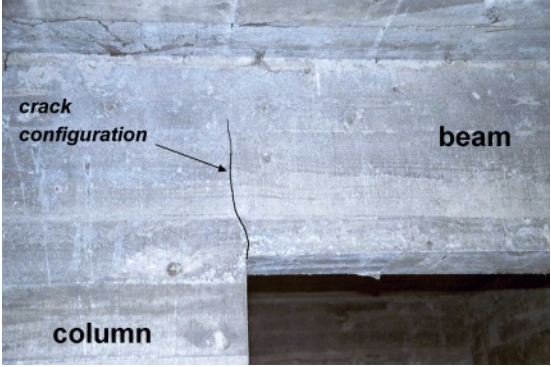
Table A5-3.4 (cont.)	Damage case: İzmit, residential building	IZT-2b
<i>Structural type</i> 6-story RC-frame structure with masonry infills		
<p data-bbox="225 427 528 456"><i>Extent of structural damage</i></p> <ul data-bbox="225 488 831 763" style="list-style-type: none"> - small cracks in columns and beams, especially at the ground story (cf. →) - few hinges have formed at column bases and beam-column joints - damage to stair landings of ground floor showing heavy spalling of concrete cover and element displacements of few centimeters - moderate to heavy damage to nonstructural masonry infill walls, especially at higher floors <div data-bbox="868 472 1422 837" style="text-align: right;">

<p data-bbox="884 568 1018 622"><i>crack configuration</i></p> <p data-bbox="1305 595 1382 624">beam</p> <p data-bbox="916 792 1018 822">column</p> </div> <p data-bbox="954 857 1334 887" style="text-align: right;">Beam-column joint at ground floor</p>

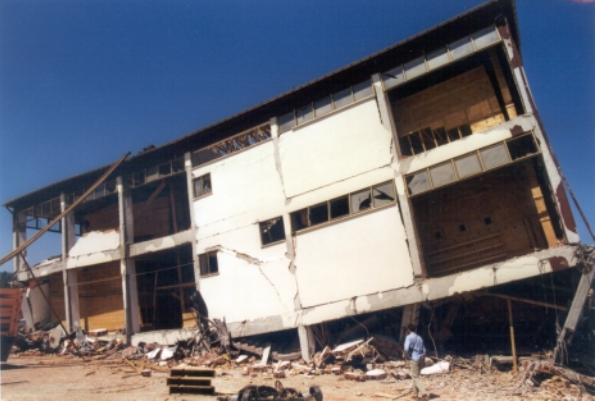
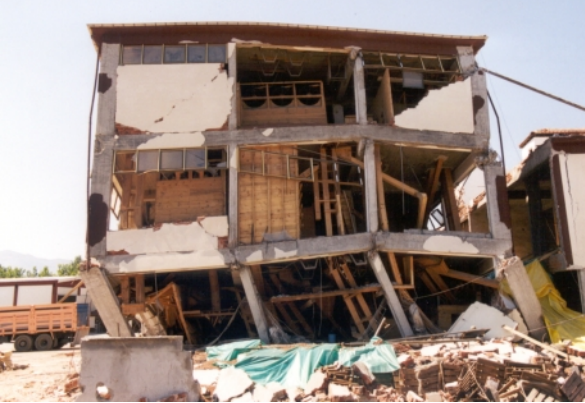
Table A5-3.10 (cont.)	Damage case: Gölyaka, Yavuzlar Fındık	YZL
<i>Structural type</i> 4-story RC-frame structure with masonry infills		
<i>Extent of structural damage</i>

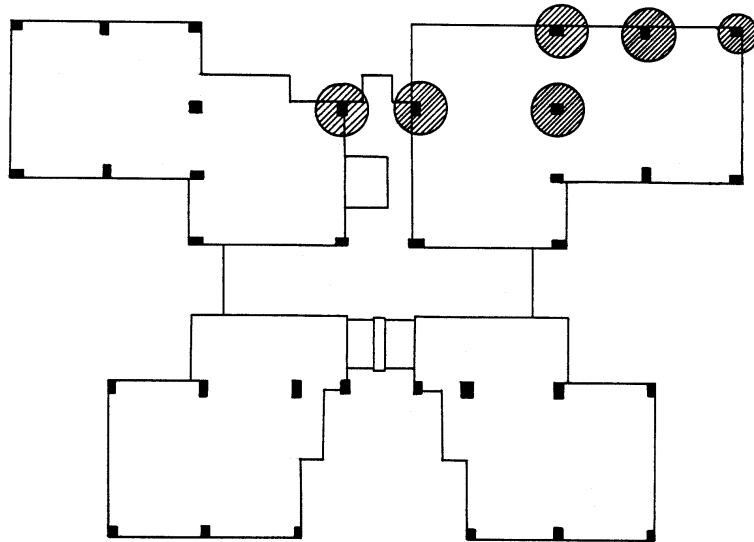
Locations of damage to structural elements of ground floor

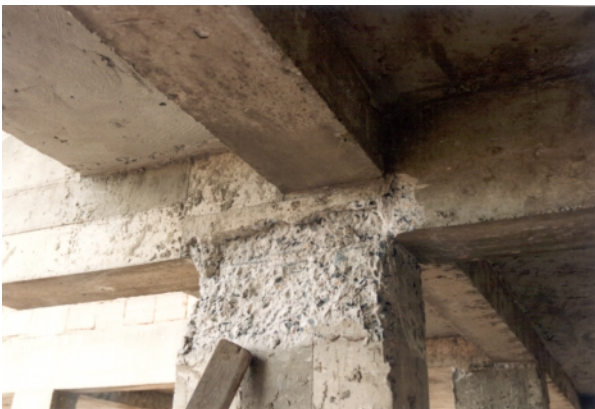
Damaged column-beam connection of ground floor

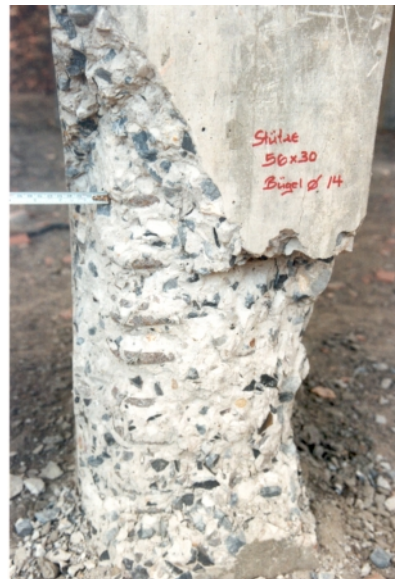
Damaged column base of ground floor

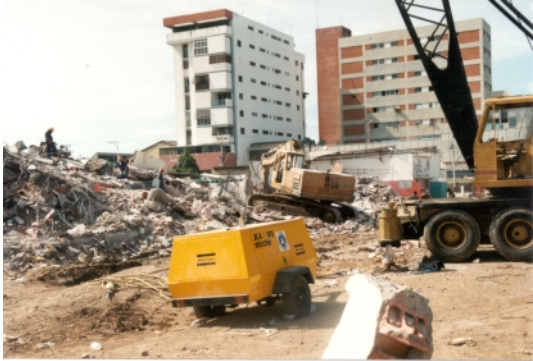
<p data-bbox="181 848 1342 916">Total collapse of the Miramar building in the front (background: multi-story buildings of similar height and structural type sustained the mainshock without any damages)</p>	
<i>Structural model</i> ¹⁾
