## Field study of the building physics properties of common building types in the Inner Himalayan valleys of Bhutan

Mark F. Jentsch<sup>a,\*</sup>, Christoph Kulle<sup>a</sup>, Tobias Bode<sup>a</sup>, Toni Pauer<sup>a</sup>, Andrea Osburg<sup>a</sup>, Tenzin<sup>b</sup>, Karma Namgyel<sup>b</sup>, Karma Euthra<sup>b</sup>, Jamyang Dukjey<sup>b</sup>, Karma Tenzin<sup>b</sup>

Building monitoring  
Air tightness  
U-value  
Indoor climate  
Himalaya  
Climate data

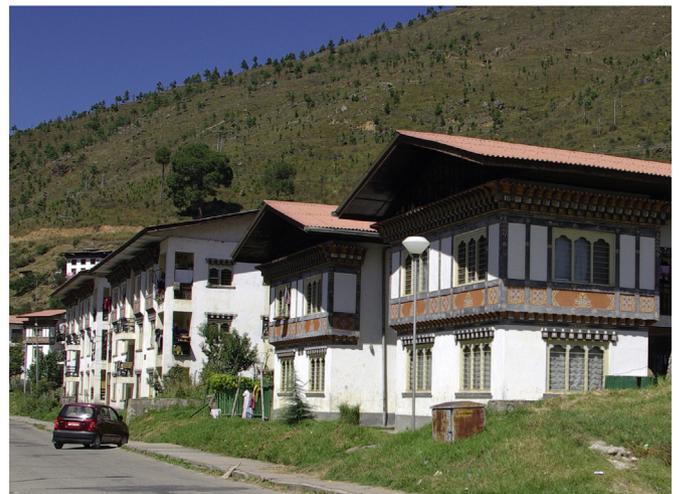
**Fig. 2.** Government constructed apartment buildings in Thimphu in reinforced concrete frame construction with brick infills and concrete formwork for architectural design elements.

for roof designs. The guidelines also permit the use of contemporary materials such as pre-cast concrete elements which, as can be seen in Fig. 2, are now commonly used for façade and window details instead of wood. The use of such precast elements is, however, often criticised by western scholars since the material requirements and the structural reasons that exist for the corresponding woodwork often no longer apply for the contemporary designs (Watson and Bertaud, 1976; Nock, 1995; Walcott, 2009; Langenbach, 2010; Herrle et al., 2014). In Bhutan itself however, the view is taken that the development of architecture should be guided by the cultural heritage, but that at the same time there should also be “flexibility for creativity and innovation for new designs” (MoWHS, 2014).

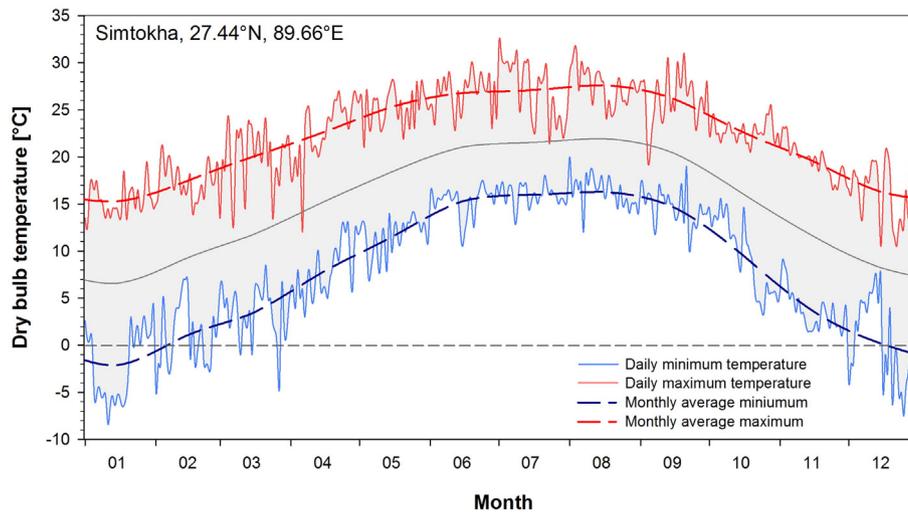
**Fig. 3.** Diurnal profile of the daily minimum and maximum dry bulb temperatures for a “typical year” in the Thimphu valley area, constructed from daily temperature data of Simtokha weather station from July 1995 to June 2014.

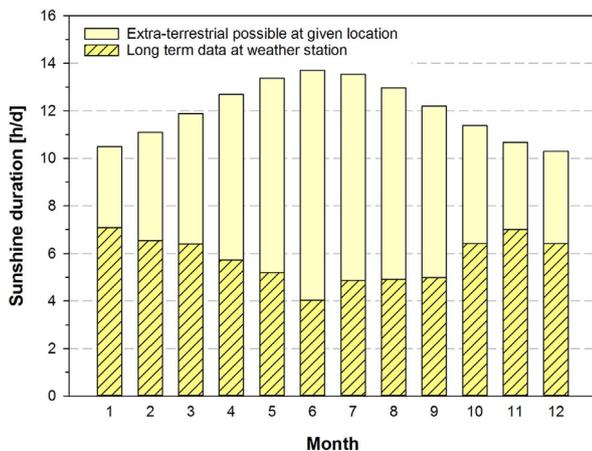
**Fig. 4.** Average daily sunshine duration for Simtokha weather station. (Data source: Department of Hydromet Services (DHMS), Bhutan)

The potential for the application of thermal mass is further illustrated in Fig. 4 which shows the average daily sunshine duration per calendar month. This data represents the median values of the available monthly data, in this case data from July 1995 to October 2014, albeit with selected months in 2002, 2007 and 2009 as well as the entire year 2011 missing from the data. It can be clearly seen, that those months with the lowest night-time minimum temperatures shown in Fig. 3 are, at the same time, the months with the longest sunshine hours. As illustrated in Fig. 4, in the four months from November to February the sunshine hours represent around 60% of what would be astronomically possible, as calculated following the solar geometry equations given in CIBSE Guide J (CIBSE, 2002). Given the latitude of Thimphu (27.47°N) and an appropriate siting of a building in relation to the local topography in order to avoid extensive shading effects, solar gains could thus be utilised in winter for supporting space heating as already highlighted in the 'Bhutan Green Building Design Guidelines' (MoWHS, 2013a).

winter. The dry winter with limited cloud cover, which is clearly visible in Figs. 4 and 5, is a further indication of the general applicability of passive design principles in order to sustain comfortable indoor climate conditions (MoWHS, 2013a). In view of this the question arises, why measures such as a high thermal mass are not more widely applied in new constructions in Thimphu, even though the benefits are clearly apparent. Fig. 5 also clearly shows the summer monsoon season typical of the Inner Himalayas which necessitates appropriate roof designs in order to avoid structural damage.

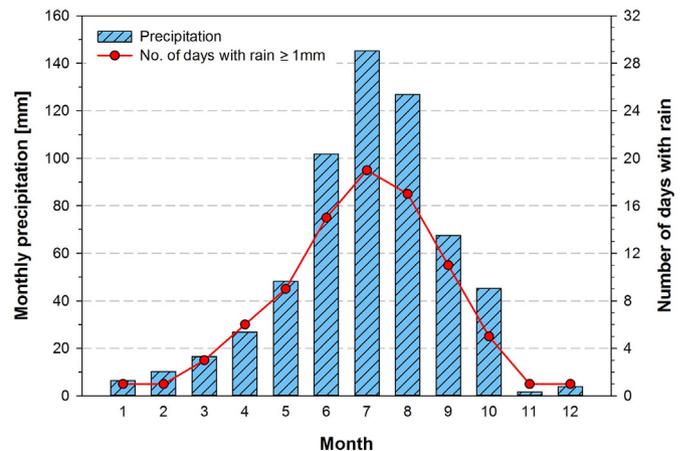
**Fig. 5.** Average precipitation and number of days with rain for Simtokha weather station. (Data source: Department of Hydromet Services (DHMS), Bhutan)

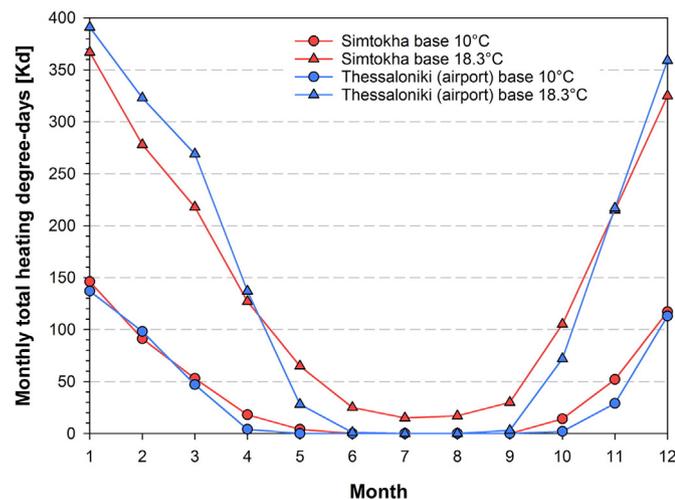
**Fig. 6.** Monthly heating degree-days for Simtokha weather station and Thessaloniki Airport for the base temperatures 10 and 18.3 °C. (Data source Thessaloniki Airport: ASHRAE, 2013)

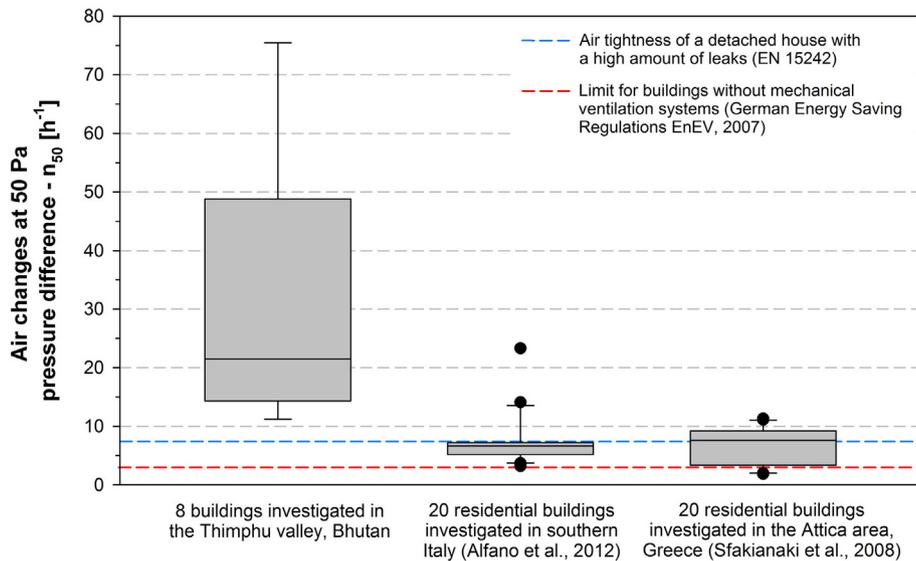
**Fig. 9.** Air changes at 50 Pa pressure difference for the 8 buildings investigated in Bhutan in comparison to air tightness tests conducted in southern Italy (Alfano et al., 2012) and in Greece (Sfakianaki et al., 2008).

The most common measure for comparing the air tightness of buildings is the air change rate at 50 Pa pressure difference, the so called  $n_{50}$  value, which represents the mean value of under- and overpressure measurements at 50 Pa (EN 13829:2000). For example, in Germany the Energy Saving Regulations (ENEc) 2007 state that the  $n_{50}$  value of a new building tested following EN 13829:2000 must not exceed  $3 \text{ h}^{-1}$ . As can be seen in Table 3 and the box plot in Fig. 9 none of the

investigated buildings in Bhutan met this requirement, with the best performing building, i.e. the social housing unit (building 8), displaying a value which is almost 4 times higher at  $n_{50} = 11.7 \text{ h}^{-1}$ . This is also higher than the value of  $7.5 \text{ h}^{-1}$  given in EN 15242:2007 for a leaky detached house and demonstrates that the values determined in the field study in Bhutan significantly exceed those for both new and existing buildings in Europe. This is further illustrated by Fig. 9 via the comparison with the work of Alfano et al. (2012) for southern Italy and Sfakianaki et al. (2008) for the Attica region in Greece. These studies both spanned 20 residential buildings of various ages in areas with some similarities to Thimphu in terms of heating degree days (ASHRAE, 2013), even though the work of Alfano et al. (2012) shows some variation in the heating degree day information for the investigated buildings which is probably related to the exact building location (coastal, inland) and altitude. It can be clearly seen in Fig. 9 that, apart from some outliers in the southern Italian study (Alfano et al., 2012), the bulk of the

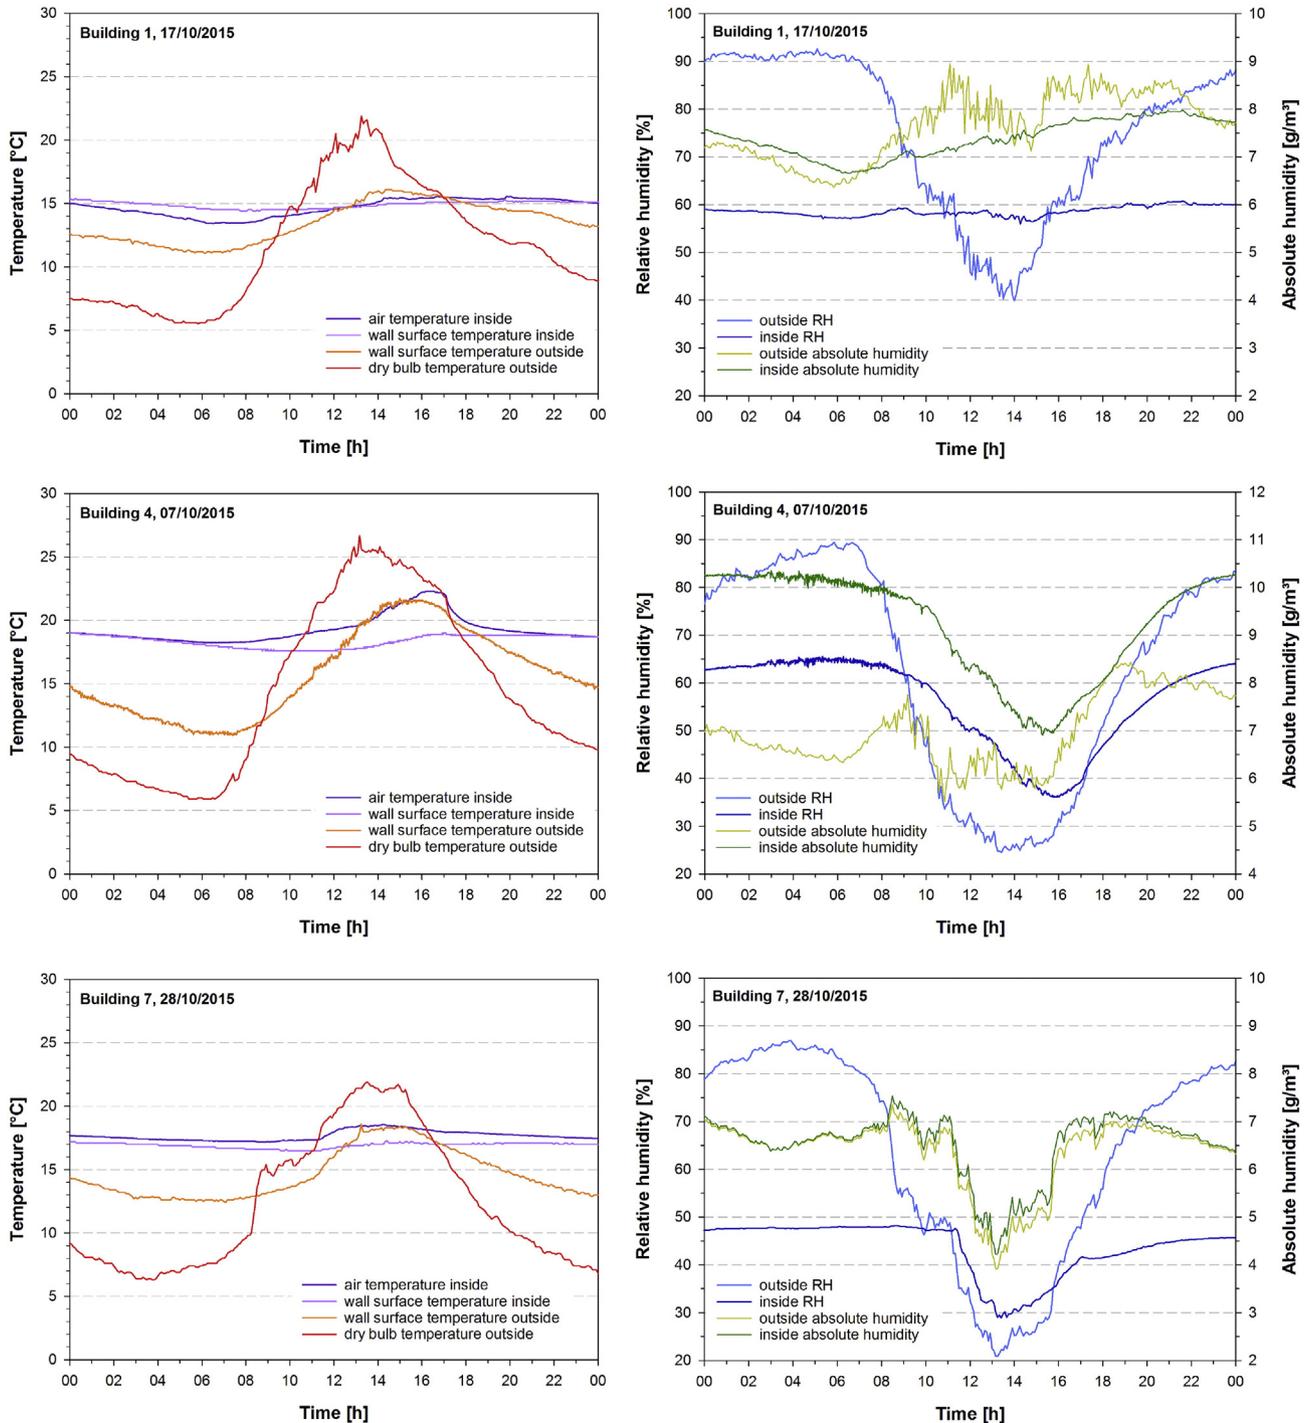
**Fig. 10.** 24-h plots of internal and external temperature as well as relative and absolute humidity data monitored in buildings 1, 4 and 7.

The remaining three spaces had in common that they were not heated or occupied during the monitoring period so that impacts from building services equipment or occupants on the results can be excluded. Fig. 10 shows 24-hour plots of these three spaces for the monitored temperature and relative humidity as well as absolute humidity data calculated from these following the guidance given by ASHRAE (2013) for determining the partial pressure of water vapour and then the ideal gas law for determining absolute humidity. The 24-hour periods shown in Fig. 10 were selected on the grounds of the dry bulb temperature

The free running nature of the buildings clearly reveals the impact of different construction types. Whilst the 77 cm thick rammed earth walls of building 1 led to rather stable but cool indoor air temperatures at a mean of 15.2 °C as well as almost unchanged relative humidity levels over the measurement period as can be seen in Table 4, building 4 with a similar material (CSEB) but significantly thinner walls at 31.6 cm showed a much higher mean internal air temperature at 19.8 °C (Table 4). This is further illustrated by Fig. 10 for a 24-hour time slot for both buildings which also shows a more pronounced temperature swing on the external north facing wall for building 4 than building 1. Given that the investigated room of building 1 was on the top floor and that of building 4 on the ground floor and that the main facades of the two rooms were facing east and west respectively, the strong temperature differences determined between the two buildings would not be expected, also since the timber-frame façade of building 1 had some broken windows and numerous air leaks. Here the impacts on the room climate of the large thermal mass walls of building 1 as well

The office room monitored in building 7 was situated on the ground floor, oriented to the west and, as detailed in Table 3, shielded from direct sunlight by an embankment with retaining wall. This shows in the internal air temperature plotted in Fig. 10 which only experiences a small rise during the day in the narrow temperature band highlighted in Table 4. Similarly, the external wall temperature shows a less pronounced swing than for building 4 with a similar wall thickness. However, it also needs to be noted that this was for a day with a less pronounced dry bulb temperature swing of about 15 °C instead of around 20 °C for building 4.

Both, Table 4 and Fig. 10 show that the relative humidity levels inside the 3 free running buildings were typically within 30 to 70% which are usually considered as the limits for meeting thermal comfort (Pistohl, 2009). Only inside building 7 the RH dropped below the 30% (Table 4). However, looking at the plots for inside and outside absolute humidity as well as the temperature data in Fig. 10, it becomes evident, that this drop is a clear function of the external weather conditions coupled with the internal temperature profile. Moreover, Fig. 10 shows a clear relation between the outside and inside absolute humidity data for building 7, which, in the absence of internal moisture sources, is as one would typically expect in a building with a high air infiltration rate such as building 7 at  $n_{inf} = 1.9 \text{ h}^{-1}$  (Table 3). Interestingly, for building 1 Fig. 10 shows a different profile for absolute humidity with a smoothed curve for the inside data relative to the outside data. This highlights the impact of the rammed earth walls with their good ability to absorb and reemit moisture, which is also described in literature (Schroeder, 2013) and which is not present in the case of building 7 with its main construction materials brick and cement. Fig. 10 also highlights a comparably large relative humidity band for building 4 and, more importantly, a strong deviation of the inside an outside absolute humidity of up to more than  $3.5 \text{ g/m}^3$  in the early morning. Given that the same sensors were used for all three buildings and that the external absolute humidity appears to match between the three days, the conclusion for the significantly higher moisture inside the building has to be the presence of a moisture source. In the absence people or plants inside the building or any activities involving water such as showers or cooking, the reasons for this are not readily apparent. However, during the monitoring of the, at the time, one year old building cracks, spalling of the external façade coating and even salt efflorescence were recorded on the base of the west facing external wall. These damages imply rising dampness inside the wall that cannot easily diffuse to the outside, thus potentially ending up inside the room. The findings regarding the water absorption of the CSEB wall and its base/foundation discussed further below as well as the absolute humidity data in Fig. 10 appear to confirm this. During the day and in particular the afternoon, when the sun was shining on the main west facing façade and the indoor air speed was highest inside the building, the absolute humidity dropped as the moisture was transported to the outside through the leaky building envelope with an air infiltration rate of  $n_{inf} = 1.9 \text{ h}^{-1}$  (Table 3). Later in the day without sun and wind (the afternoon is typically the windiest time in the Thimphu valley) the difference between outside and inside absolute humidity increased again (Fig. 10). Overall, this case of a building which, for earthquake resistance reasons, does not have horizontal sealing against rising dampness highlights the complexity and risks of, for example, suggesting improvements to air tightness without at the same time considering the construction methods that are employed.

- Bhutanese earth based wall materials can, in conjunction with their large mass, help to retain stable relative humidity conditions within a comfortable band by maintaining stable temperature conditions and by absorbing and releasing moisture as demonstrated by the absolute humidity data shown in Fig. 10 for building 1.

reversing of the heat flux  $\phi$  [W] through the wall (ISO 9869-1:2014). As can be seen in Fig. 10, this was not the case for the free running buildings investigated in Bhutan since the external air temperatures exceeded the internal temperatures by several Kelvin in the middle of the day. Therefore, the spaces investigated for their wall U-values were fitted with electric heaters in order to ensure stable inside temperature conditions above the external dry bulb temperature. Nevertheless, the strong daily temperature swing of course remains as an important influencing factor.

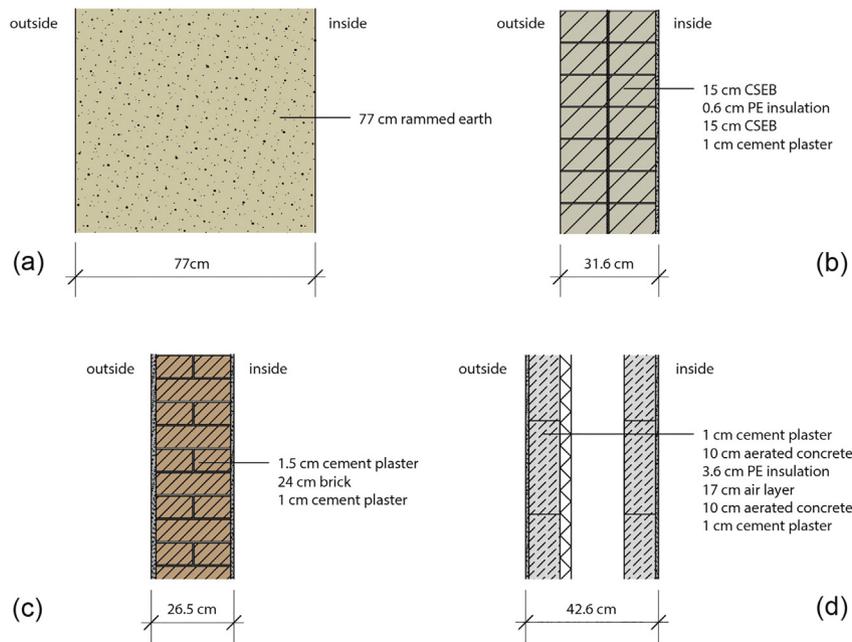
**Fig. 11.** Structure of the four investigated walls in Thimphu: (a) rammed earth wall, (b) cement stabilised earth block wall, (c) brick wall and (d) aerated concrete block wall.

Since no thermal conductivity information was available for any of the building materials shown in Fig. 11, it had to be inferred in order to be able to determine U-values for comparison with the measured data. Rammed earth walls are quoted to typically have a gross dry density of 1800 to 2200 kg/m<sup>3</sup> (Schroeder, 2013). Therefore, it was assumed that the rammed earth wall investigated in Bhutan had a gross dry density of 2000 kg/m<sup>3</sup> for which DIN 4108–4:2013 specifies a thermal conductivity of 1.1 W/m<sup>2</sup> K. The gross dry density of the Bhutanese cement stabilised earth blocks was determined at 2000 kg/m<sup>3</sup> in laboratory assessments. Looking at thermal conductivity data published by Adam and Jones (1995), Webb (1988) and the ILO (1987) for CSEBs of various soils a thermal conductivity of 0.61 W/mK was inferred via linear regression for a block of a gross dry density of 2000 kg/m<sup>3</sup>. The gross dry density of the bricks and the aerated concrete blocks used in Bhutan were determined locally at 1300 kg/m<sup>3</sup> and 650 kg/m<sup>3</sup> respectively. According to the data given in DIN 4108–4:2013 this corresponds to thermal conductivities of 0.53 W/mK and 0.21 W/mK respectively. For the cement plaster and the PE insulation used in some of the buildings the standard values provided in ISO 10456:2007 + Cor. 1:2009 were

assumed. In the case of the aerated concrete block wall the large air layer shown in Fig. 11 was considered with a thermal resistance of 0.17 m<sup>2</sup>K/W following the recommendations given in ISO 6946:2007. As can be seen in Table 5, the calculated U-values are similar to those determined in-situ, albeit generally slightly higher. However, as the exact thermal properties of the building materials are largely unknown, it can be concluded that the U-values determined in the measurements appear to be plausible.

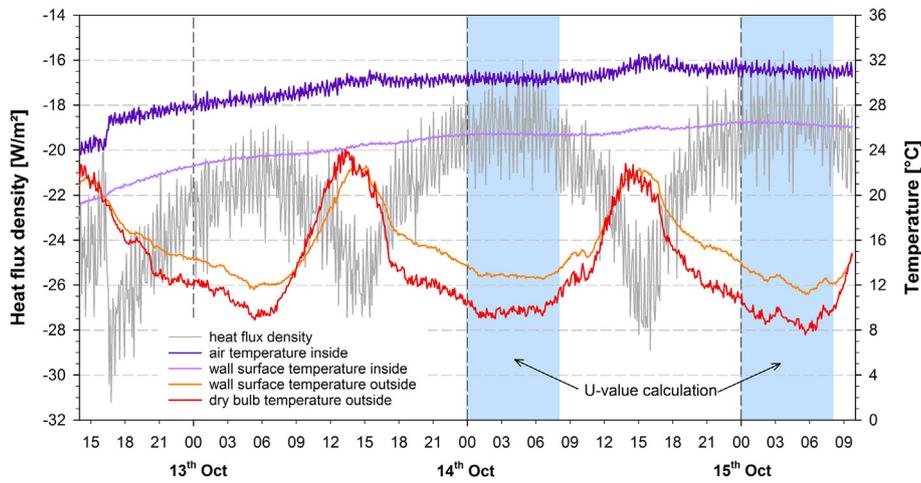
Fig. 12. Building 4, monitoring of inside and outside surface/air temperatures as well as heat flux density of the heated space for determining wall U-values.

Fig. 12 shows the air and surface temperatures measured on the north facing wall of the CSEB building 4 as well as the heat flux density through the wall, with the negative values for the heat flux density denoting a heat flux from the room towards the outside. It can be clearly seen that, following the installation of electric heaters, it took more than 30 h for the internal air temperature and the inside surface temperature to level out to some extent. Furthermore, the heat flux density displays a remarkable pattern that appears counterintuitive in that a greater heat flux from the inside to the wall is visible during the daytime than during the night when the temperature difference between the internal and external surfaces is greatest. The explanation for this appears to be the wall's thermal mass. During the night there is a constant heat loss to the outside, leading to rather stable conditions. During the day, when the heat loss to the outside is smaller, more energy can be transferred to the wall to be released at a later stage.

A further unclear point seen in Fig. 12 is the observed scatter of the internal air temperature of about 1.5 °C as well as the corresponding scatter of the heat flux density. This appears to be related to the electric heating installed for the monitoring as Fig. 13 demonstrates which shows the data for the entire measurement period from noontime on the 15<sup>th</sup> to the morning of the 21<sup>st</sup> of October 2015 in the historic rammed earth building 1, i.e. the indoor climate assessment and the U-value determination test with heated space. When the heater is not running, no scatter is observed for either indoor air temperature or the heat flux density. This also shows in the power failure event on the 20<sup>th</sup> of October. Furthermore, during the free running indoor climate assessments on the 16<sup>th</sup> and 17<sup>th</sup> of October, one can clearly see a small heat flux from the inside of the room to the wall as the temperatures rise during the daytime. Conversely, during the night time low there is a heat flux from the wall to the room, highlighting the effect of the wall releasing energy back to the room as a result of its thermal capacity. This supports the findings detailed above for the heat flux density observed during the U-value determination tests in building 4. However,

As shown in Fig. 12 wall U-values were only calculated during the night-time hours when the temperature and heat flux conditions were comparably stable. Overall it can be concluded that typical historic as well as current wall constructions, i.e. buildings 1, 4 and 7, appear to have comparably high U-values of about 1.0 to 1.5 W/m<sup>2</sup> K which match those of similar constructions with known U-values (CIBSE, 2015). This is further illustrated by Table 5 which highlights the U-values determined in the measurements in comparison to calculated U-values. However, it is also important to note that the true surface resistances  $R_{si}$  and  $R_{se}$  calculated using the measured surface and air

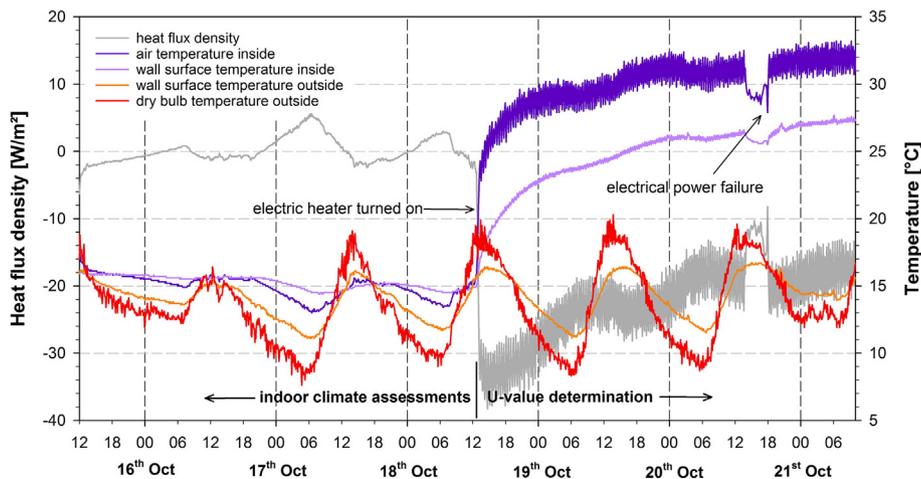
Fig. 13. Building 1, monitoring of inside and outside surface/air temperatures as well as heat flux density of the unheated/heated space for assessing the indoor climate/determining wall U-values.
