TESTING OF CONNECTIONS TAKEN FROM OLD NAILED ROOF TRUSSES

ABSTRACT: Experimental testing of nailed connections taken from old roof trusses is presented in this paper. To enable the further use and preservation of nailed roof trusses, it is important to understand how the nail corrosion and aging processes of steel and wood affect the load-bearing capacity and deformation behaviour of such structures. The hypothesis was investigated whether corroded nails allow an increase in load-bearing capacity. Several old and new joints were tested in a first test series, and the results were very promising regarding the initial assumption. However, more tests must be carried out to verify the results.

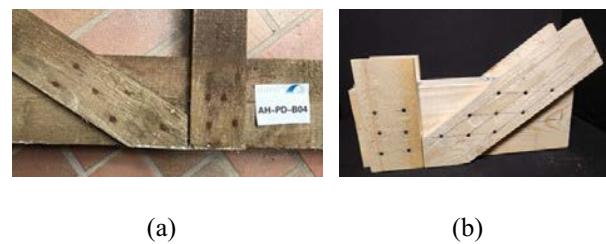
Figure 1: (a) Type-I_old: joint B04 and (b) Type-I_new: joint SV-1947-01

nail corrosion, affects the load-bearing capacity and the deformation behaviour of the nailed joints was undertaken. The basic assumption of a potential increase in the load-bearing capacity due to partially corroded nails was investigated by tests on aged joints from nailed roof trusses taken from existing buildings. The truss nodes were examined with a newly developed testing device. Additional tests were carried out on single components to analyse their specific properties and determine parameters. This can provide conclusions about differences between the aged connections and new construction. Therefore, geometrically identical node connections were produced with new materials and tested (see Figure 1). All test results will be compared and discussed in the following.

The elements selected for the second group (Type I-new) were made with new materials and served as a reference to evaluate the load-deformation behaviour of aged elements (see Figure 1). The specimens in the second group are identical to those taken from the trusses to be comparable to each other.

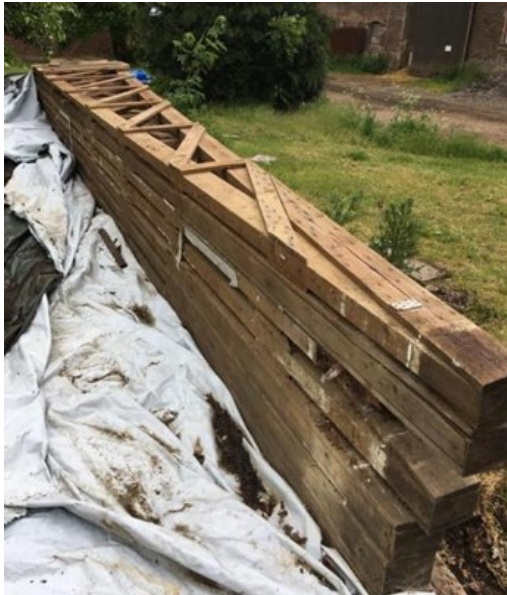
Figure 2: Roof trusses

outside under a tarp sheathing for several years (see Figure 2). This structure has been exposed over time to different climatic conditions, which have caused significant corrosion at the joints and local cracks to appear in the timber. On the other hand, some nodes are completely undamaged, so, there was a wide range between intact and considerably damaged nodes.

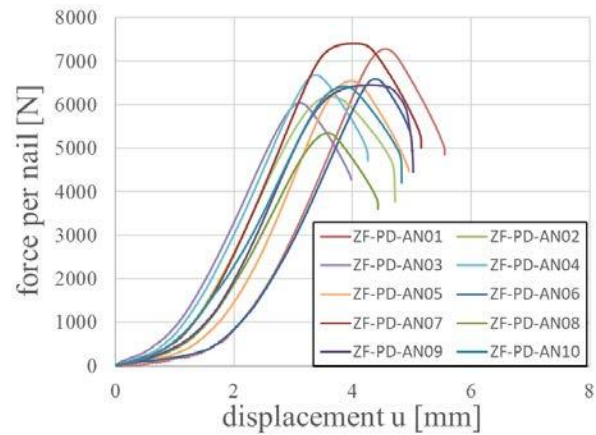
Figure 9: Tensile strength test results with corroded nails

Three different test series were carried out to determine the tensile strength of the nails. Nails with corrosion were taken from the aged roof trusses for the first test series. The second series of tests was also on nails from aged roof trusses but with the difference that the nails were galvanized. This layer protected the nails from corrosion. The third test series was on new nails. When testing the tensile strength of the nails from the first test series, it was interesting to see failure always occurring in a zone of the nails which was originally situated close to the contact surface between the middle and side parts. This can be an indication of slightly higher corrosion in the small gap between the two timber parts. The specimens tested are

depicted in Figure 8. The test results are shown in Figure 9 to 11.

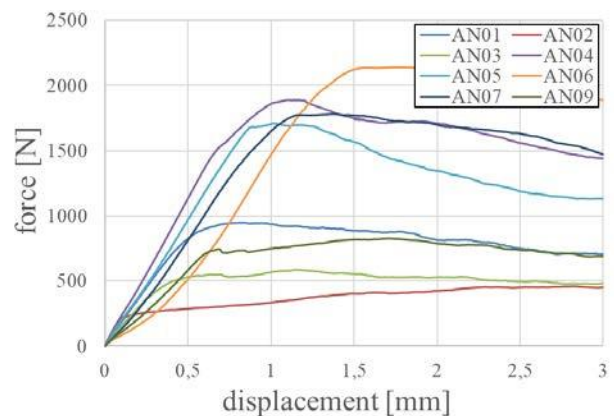
Figure 12: Withdrawal strength test results with corroded nails

The withdrawal strength is generally subject to a high degree of scattering, which is why the results are not very robust and, together with the characteristic value, the minimum value determined in the tests is given in Table 2. Consequently, further tests are required. Old nails were assigned their original diameter for the calculation of the withdrawal strength due to the small amount of corroded material. The result of each test for the old nails is given in Table 4. The test results for corroded nails taken from the first test series with the tests AF-AN-01 to -09 are shown in Figure 12. The test results for galvanized nails taken from the second test series with the tests AF-BN-01 to -10 are shown in Figure 13.

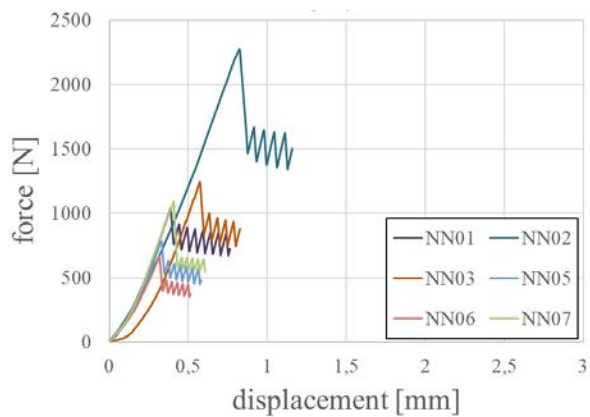
Figure 14: Withdrawal strength test results with new nails

The test results made with new materials are given in Table 5 and shown in Figure 14.

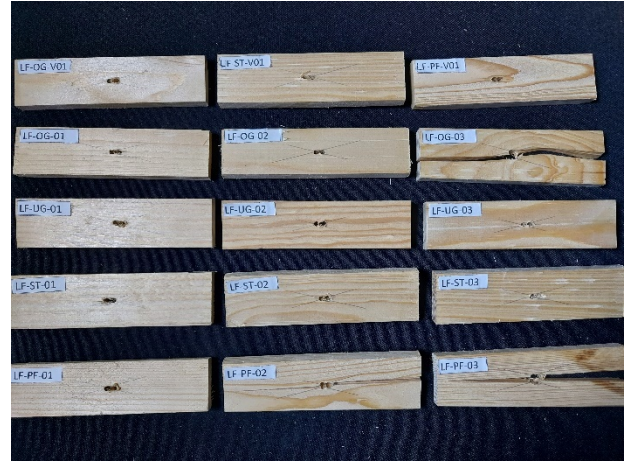
Figure 15: Embedment strength: specimens after the test

The test specimens for the embedment strength test are shown in Figure 15. As specified in the standard, all tests were performed perpendicular to the grain. The characteristic value of the embedment strength is almost identical for the chord and the strut, but the strut shows a significantly higher scattering. Results are summarised in Table 2.
