Determination of Bonding Failures in Transparent Materials with Non-Destructive Methods—Evaluation of Climatically Stressed Glued and Laminated Glass Compounds

Christin Sirtl[1], Matthias Kraus[1], Christiane Hadlich[2], Andrea Osburg[2]

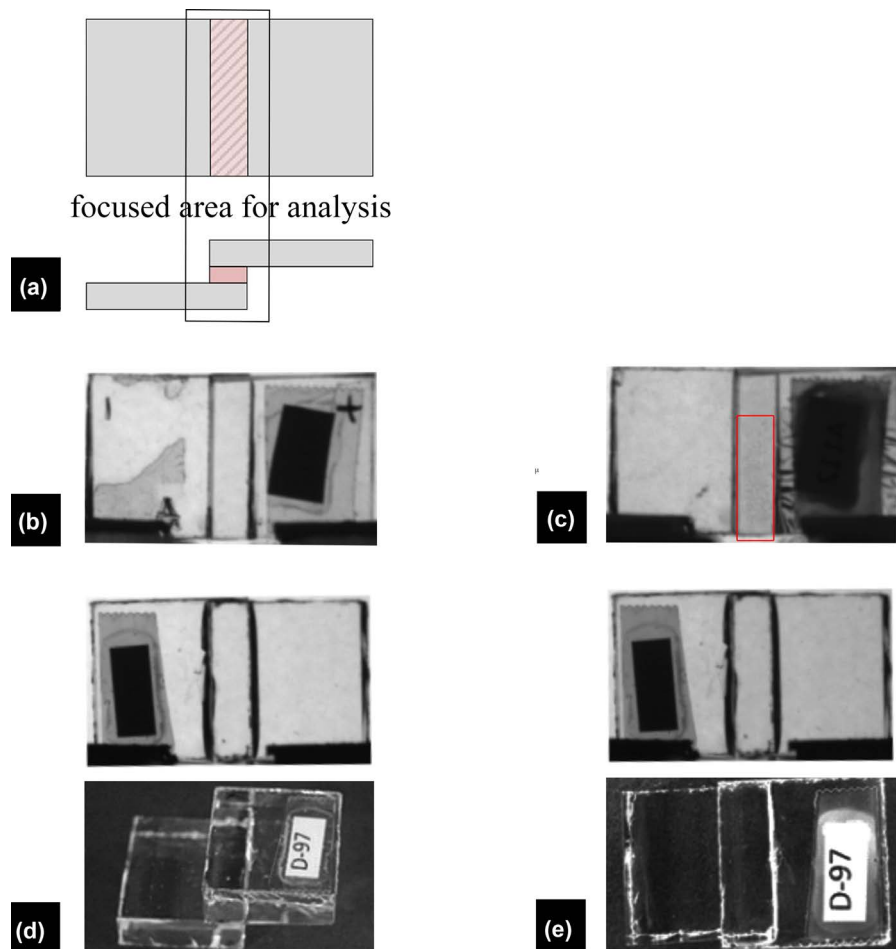
The cloudiness of an adhesive after artificial aging does not necessarily indicate a critical loss of strength, however, the material does not meet the optical demands defined in Table 1. The specimens are evaluated in the overlapping zone as depicted in Figures 4(a)-(c) show the analyses of specimen A112 (acrylate) before and after artificial aging (TF). Before loading, the visual examination does not reveal any disturbance in the overlapping area (Figure 4(a)), while after 10 days of fluidic storage and alternating temperature loading, a slight cloudiness is detected appearing as grey dotted pattern (marked area in Figure 4(c)).

The photographs of specimen D97 (EVA) before and after artificial aging are shown in Figure 4(d) and Figure 4(e). In compliance to the acrylate, no conspicuity is detected previous to the aging process (Figure 4(d)). And even after 10 days of artificial aging (TF) no changes or damages are visibly recognizable (Figure 4(e)).

Figure 4. Visual analysis, (a) description of analyzed zone, (b) specimen A112—before climatic loading, (c) specimen A112—after climatic loading (10 days, TF), (d) specimen D97 before climatic loading, (e) specimen D97 after climatic loading (10 days, TF).

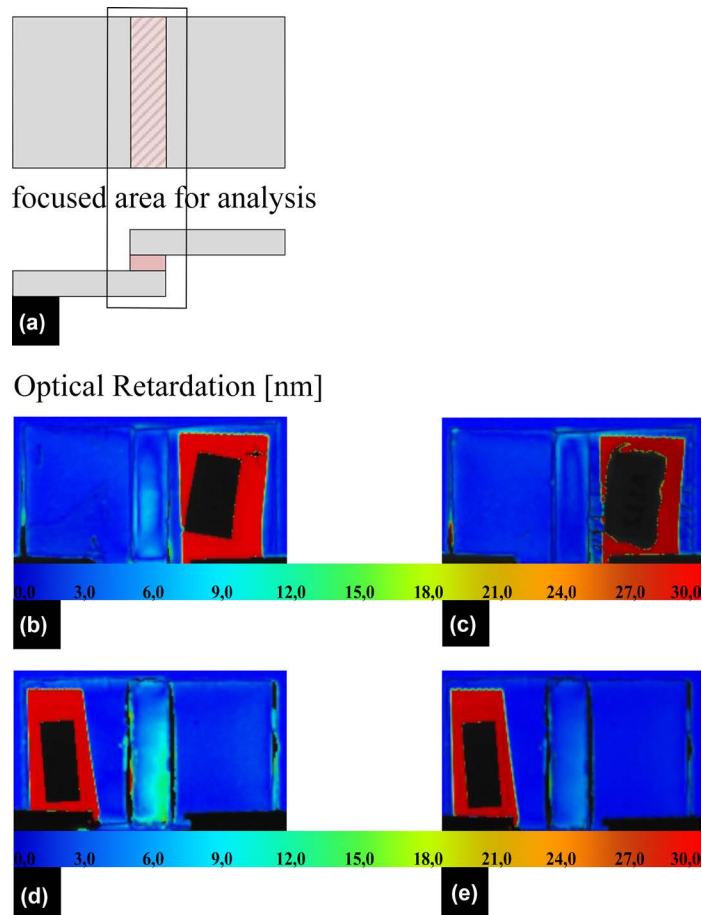
Figure 5, the results of specimens A112 (acrylate) and D97 (EVA) are shown. The dark red and black areas are caused by the labelling of the specimens (for reasons of identification). They are not considered in the evaluation, only the overlapping zone is of importance (Figure 5(a)). Before artificial aging, specimen A112 shows certain stress differences in the lower bonding area (R ≈ 9.0 nm, Figure 5(b)). After aging of 10 days (TF), these differences disappear. The area of relaxation corresponds to the detected visual changes in Figure 4(c) (gray dotted area). An increase of stress differences is visible in the upper half of the bonding area.

For specimen D97, distinct stress differences (R ≈ 12.0 nm, Figure 5(d)) are visible in the total bonding area after the manufacturing process. After artificial aging of 10 days (TF), a slight decrease is noticeable (Figure 5(e)). This relaxation is not detectable in the visual analysis (Figure 4(e)).

Figure 5. Optical retardation, (a) description of analyzed area, (b) specimen A112—before climatic loading, (c) specimen A112—after climatic loading (10 days, TF), (d) specimen D97 before climatic loading, (e) specimen D97 after climatic loading (10 days, TF).

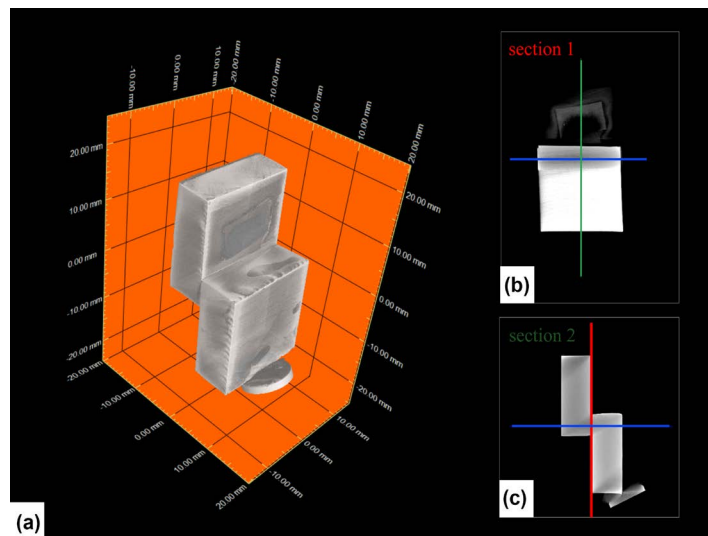
Figure 6(a) shows a full 3D computed tomographic volume data set of a lap joint specimen. The round plate at the bottom is part of the specimen holding system in the CT and not relevant for the evaluation. Figure 6(b) and Figure 6(c) show the relevant cutting planes within the sample. With the help of the

Figure 6. Computed tomographic data set, (a) full 3D CT scan of lap joint specimen, (b) analyzing section for evaluation of bonding layer (Section 1), (c) relevant section layer in middle of bonding layer.

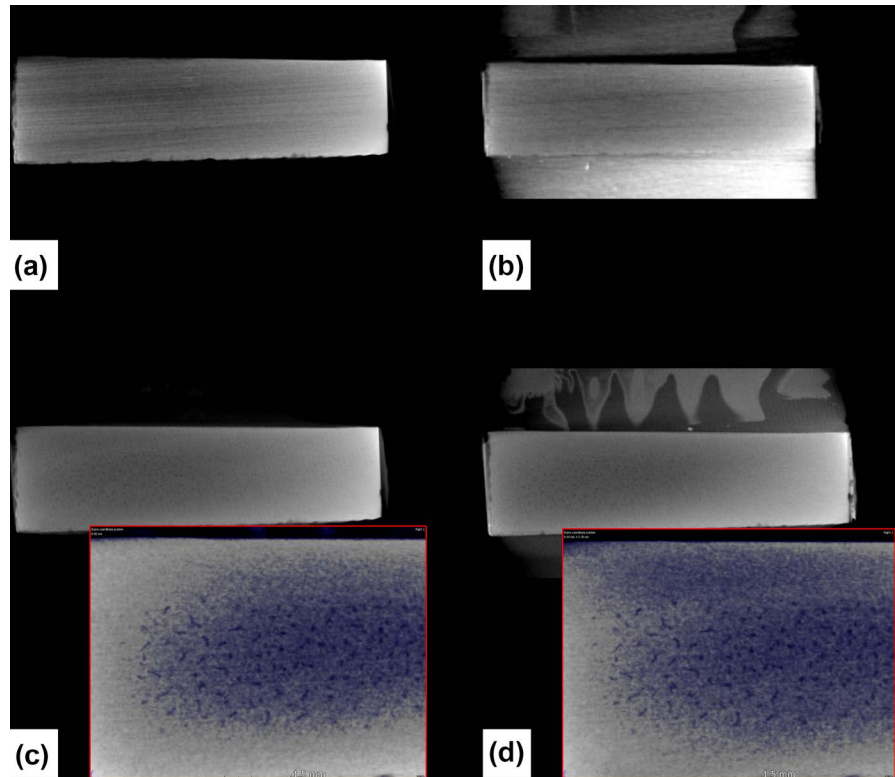
Specimen A112 does not show irregularities in the individual layer images within the bonding before loading (Figure 7(a) and Figure 7(b)). After an artificial aging process of 10 days (TF), small cracks are visible in the acrylate (Figure 7(c) and (Figure 7(d))) with length of 0.10 mm to 0.26 mm. In an enlargement, these cracks can be detected over the entire adhesive layer thickness (highlighted blue by threshold methods). In the integrated layer image these irregularities are also clearly visible (Figure 7(d)). The cracks revealed by the computed tomographic images are not recognizable in the visual analysis. They are an indication of the stress reduction, which is clearly detectable by the decrease of optical retardation (Figure 5(c)).

Figure 7. Computed tomographic images of specimen A112—computed tomographic data before (a) image in the middle of bonding layer, (b) average result over bonding layer) and after climate loading (TF) of 10 days, (c) middle of bonding layer, (d) average result over bonding layer with blue highlighting of density differences).

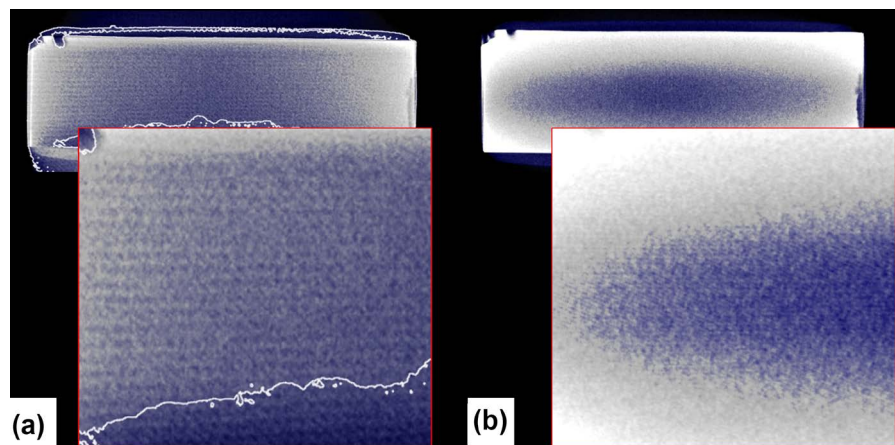
The computed tomographic image in the middle of the bonding layer of specimen D97 (Figure 8(a)) shows a certain lined structure (highlighted in dark blue). However, this phenomenon is not related to the material but based on artefacts. After the aging process of 10 days TF, it is not visible anymore. In comparison to specimen A112 (Figure 7(d)), the blue coloring in Figure 8(b) does not reveal any specific changes due to the climatic loading.

Figure 8. Computed tomographic images of specimen D97—computed tomographic data before (a) image in the middle of bonding layer) and after climate loading (TF) of 10 days (b) image in the middle of bonding layer with blue highlighting of density differences).

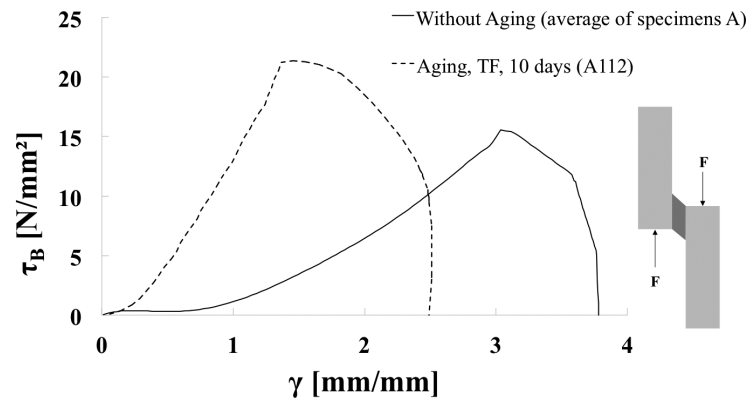
The connections bonded by acrylate A show a nonlinear material behavior without considering aging effects (**Figure 9**, without aging effects, average of specimen A). In comparison, specimen A112 behaves quite different after 10 days of artificial aging (TF). The material seems to show a certain embrittlement

Figure 9. Lap join test—τ_B-γ diagram, bonding material A—without aging effects (average of series A) and with aging effect TF, 10 days (specimen A112).

over time—indicated by the decreased strain ability with a simultaneous increase of shear strength (**Figure 9**, Aging, TF, 10 days, specimen A112). This is also indicated by the results of the computed tomographic data (**Figure 7**): the small cracks point to this conclusion as well. The material behavior of different specimens in this series shows a wide variety regarding stiffness as well as shear strength under aging effects. Furthermore, the failure mode is not consistent—both, cohesion and adhesion failures are observed. The aging under temperature changes and fluidic storage seems to have diverse influences on the material. However, a cause investigation of the phenomenological effects is not accomplishable using the described methods and not subject of this research.

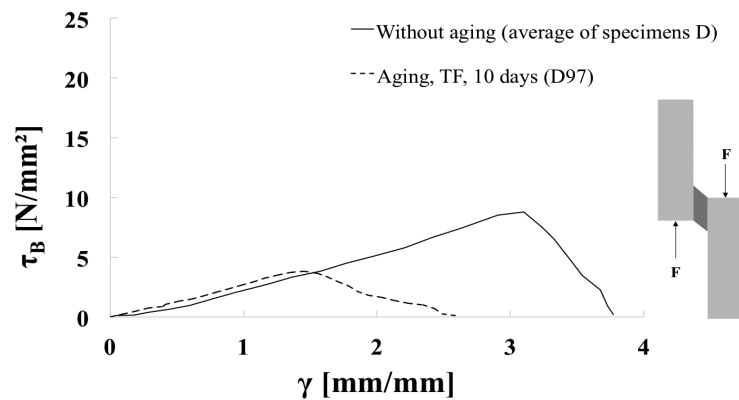
Figure 10. Lap join test—τ_B-γ diagram, bonding material D—without aging effects (average of series D) and with aging effect TF, 10 days (specimen D97).

Figure 10 shows the results of specimens with bonding material D. Without the influence of artificial aging, the stiffness behavior of the joint before failure can be described as quasi linear (**Figure 10**, without aging effect, average of specimen D). After artificial aging TF of 10 days, specimen D97 shows a distinct decrease of shear strength (**Figure 10**, Aging, TF, 10 days, D97) at a similar stiffness level. Different specimens under aging influences in this series show a

wide variety of shear strength, however, stiffness levels are always quite equal. As failure modus, an adhesion failure is observed for all specimens in this series. It seems that the artificial aging has negative influence on the bonding (adhesion forces) in the interface layer. Specific influences leading to this failure cannot be detected in the computed tomographic data (Figure 8). However, with the analysis of birefringent properties a decrease of optical retardation (Figure 6) is visible.
