Annex 5

A5-3 Documentation of damage cases

Table A5-3.1	Sultandağı, residential building	(SUL)
Table A5-3.2	İzmit, residential building	(IZT-1)
Table A5-3.3	İzmit, residential building	(IZT-2a)
Table A5-3.4	İzmit, residential building	(IZT-2b)
Table A5-3.5	İzmit, residential building	(IZT-2c)
Table A5-3.6	Düzce, residential building	(DUZ-1)
Table A5-3.7	Düzce, residential building	(DUZ-2)
Table A5-3.8	Seymen, residential building	(SEM)
Table A5-3.9	Sapanca, residential building	(SAC)
Table A5-3.10	Gölyaka, Yavuzlar Fındık	(YZL)
Table A5-3.11	Cumaná, Avenida Perimetral	(AVE)
Table A5-3.12	Cumaná, Edificio Miramar	(MIR)
Table A5-3.13	Cumaná, Edificio Residencial	(EDR)
Table A5-3.14	Cumaná, Edificio de oficinas Toyota	(TOY)

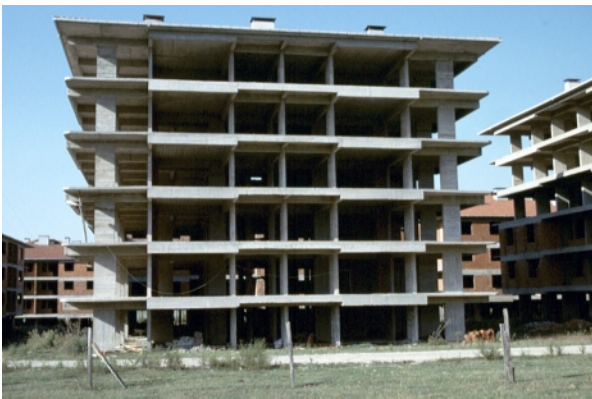
General view of the east facade

<i>Description of the structure</i>			
Year of construction:	1999	Elevation design:	regular
Anti-seismic design:	no	Plan design:	regular
Type of use:	residential building	Type of foundation:	RC plate foundation
No. of stories:	6	Type of slabs:	reinforced-concrete ($t = 0.12$ m)
Basement:	0	Type of infills:	no
Cores:	1 (elevator shaft)	Grade of damage:	DG (EMS-98) = 3

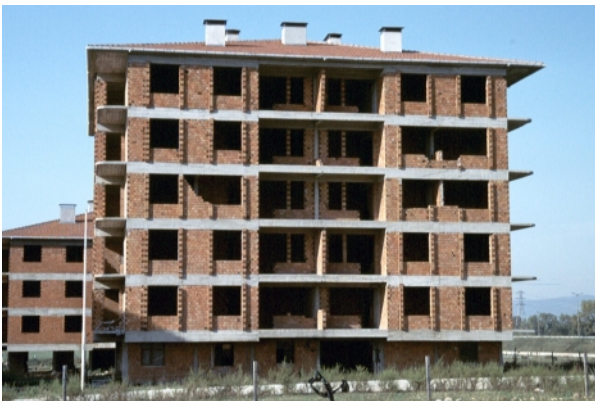
General view of the east facade

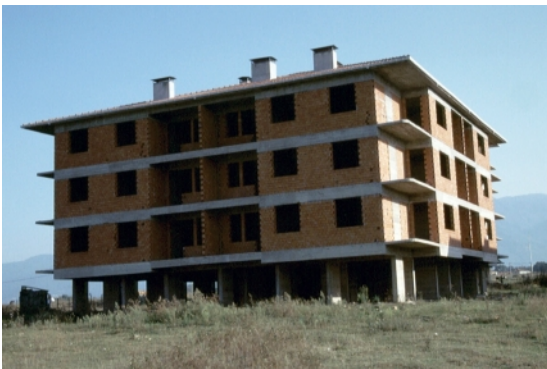
General view of the north facade

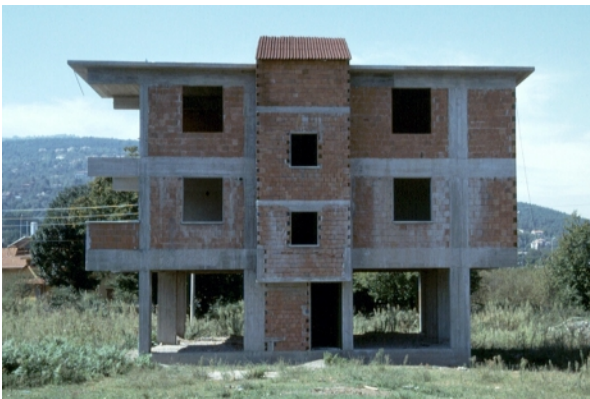
General view of the east facade

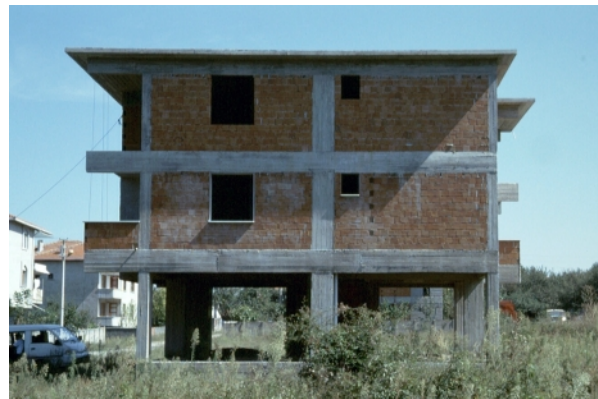
General view of the west facade

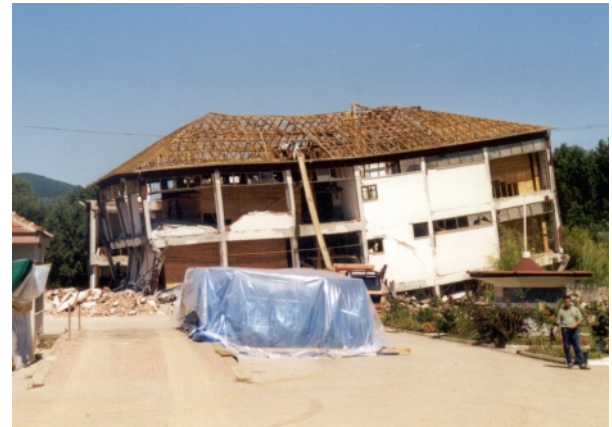
General view after the damaging 1999 İzmit (Kocaeli) earthquake

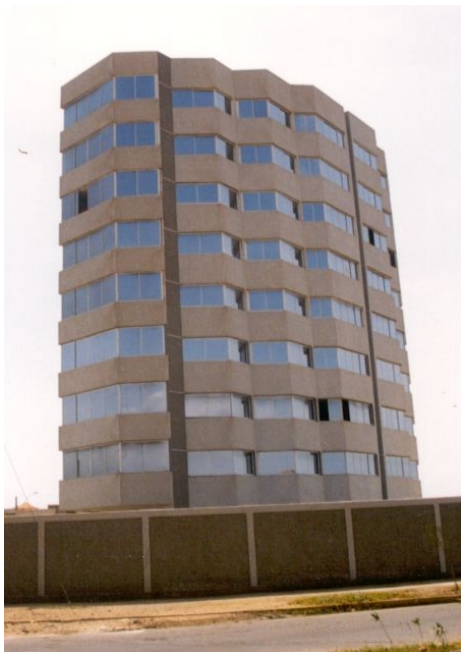
General view of the north facade
