APPENDIX  
QUICK GUIDE TO CASE STUDIES

**CASE STUDY'S TIMELINES - PHOTOS FROM DWELLINGS AND THE FROM LOCAL URBAN ENVIRONMENT<sup>12</sup>**

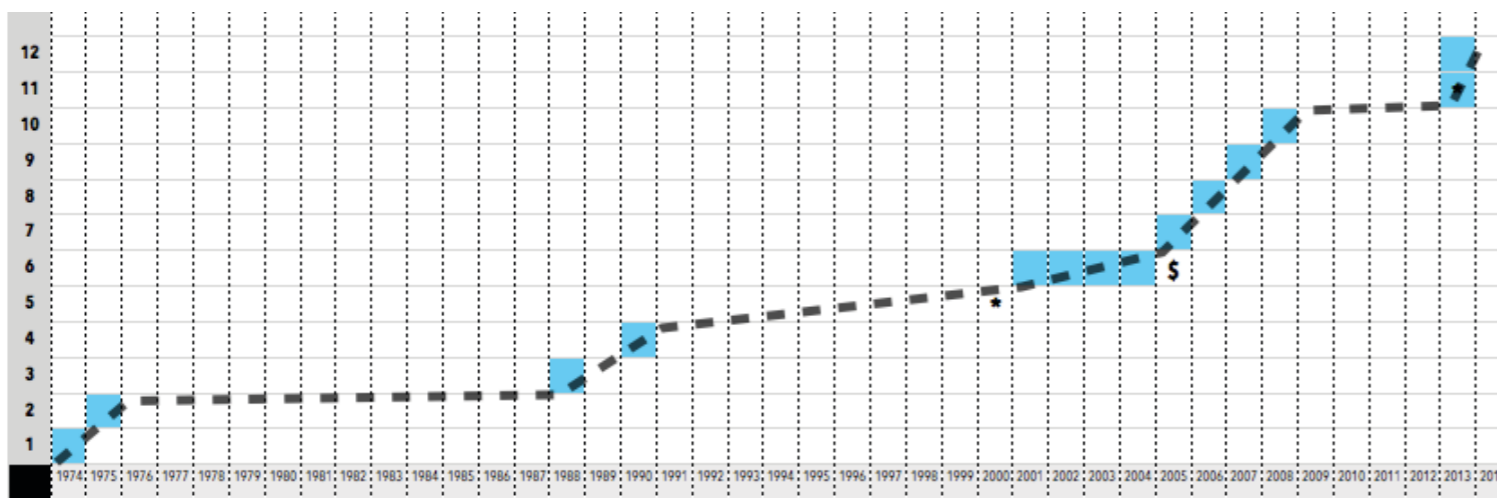
1	1974	Arrival and purchase of plot with single-room hut and detached toilet
2	1975	Installation of fence made of mattress springs and a metallic roof
3	1988	Construction of toilet attached the house
4	1990	Construction of concrete slab on the top of a ravine
5	1997	Construction of a new kitchen
6	2000	Purchase of land besides and demolition of existent house
7	2001	Start new construction (ground floor): 2 rooms, toilet, open kitchen, stairs (5months)
8	2002	Start construction upper floor
9	2004	Finish construction ground- and upper floor
10	2005	Construction of chicken stall
11	2006	Montage of <i>varanda colonial</i> at the back
12	2007	Construction of garage
13	2008	Construction additional bedroom
14	2013	Purchase another land besides and demolition existent house
15	2013	Construction of pizzeria and external stairs to access rooftop

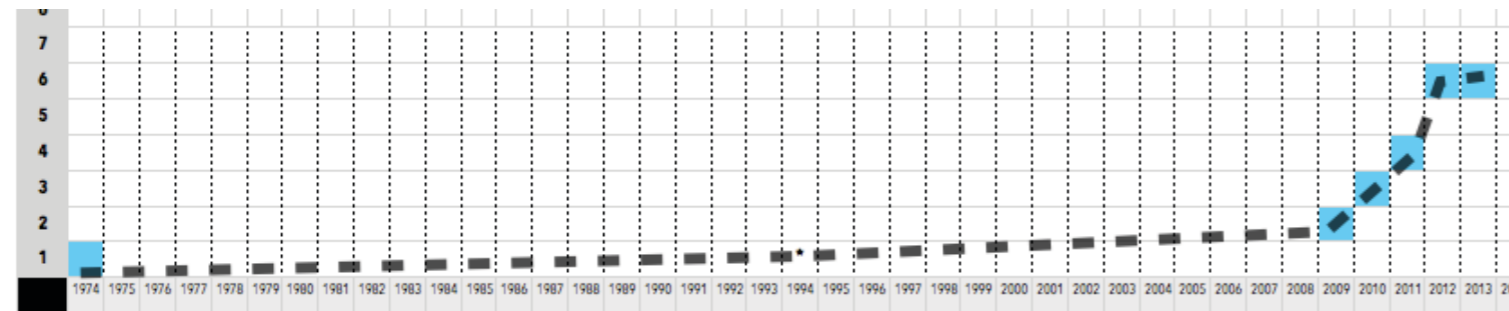
1	1975	Arrival, purchase of land and construction of single-room with kitchen (another spot), repeated improvements, turned to be a three-floor building
2	1994	Purchase of another plot (current location)
3	2001-2004	Construction of three-floor building
4	2009	Removal, construction of another small hut and moving in
5	2009-2012	Improvement of hut, construction of two houses and a bar
6	2013-2014	Construction of two housing units (underground- and upper floor)

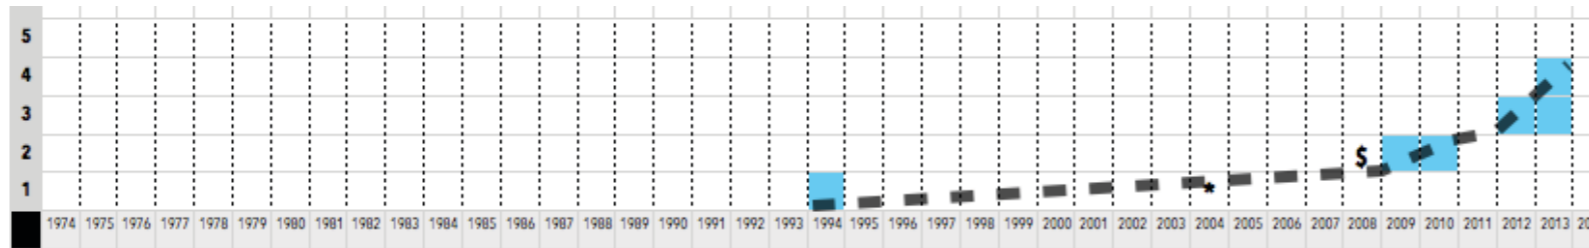
1	1994	Arrival. Lives with his sister (cohabitation)
2	2004	Purchase of the land
3	2009-2010	Construction first floor, without external finishings
4	2012-2013	Construction second floor, without external finishings
5	2013-2014	Construction third floor, without external finishings

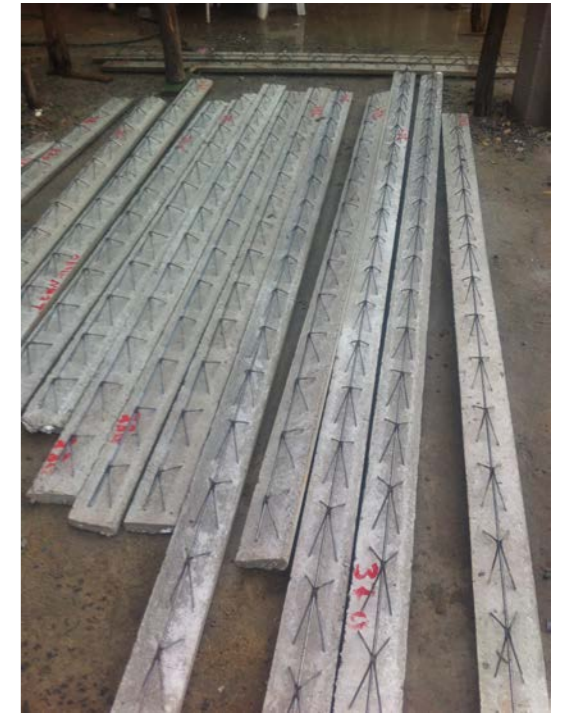
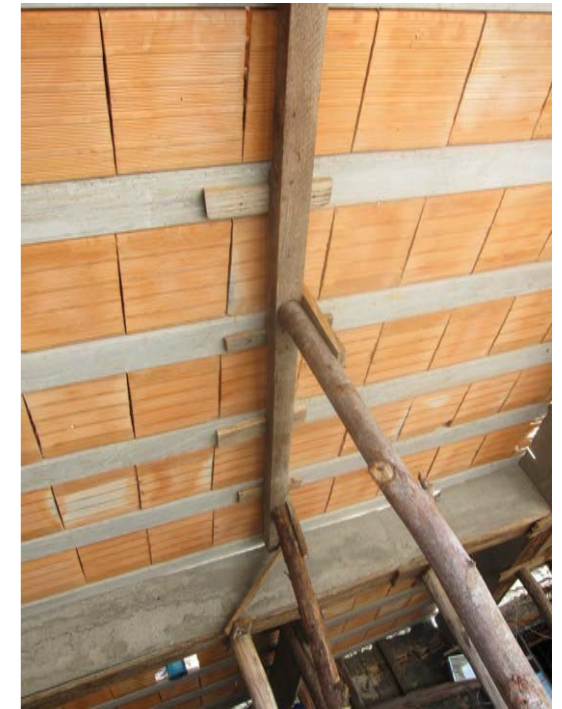
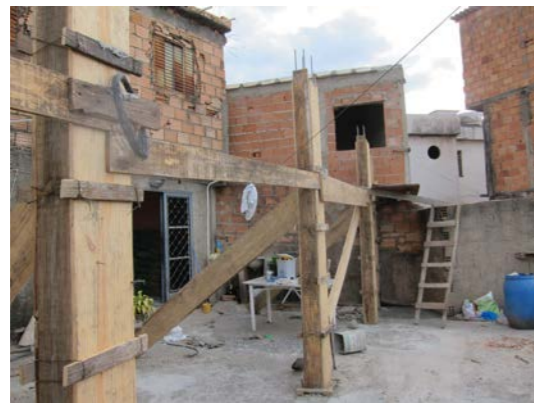
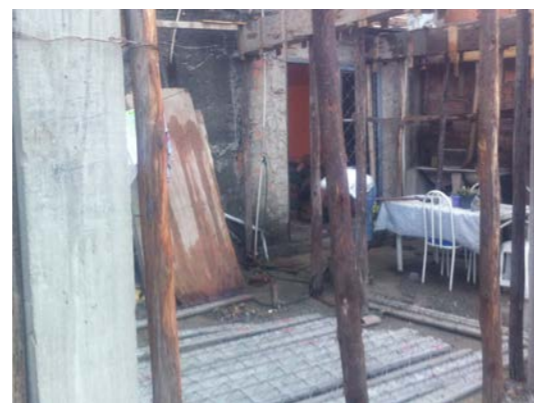
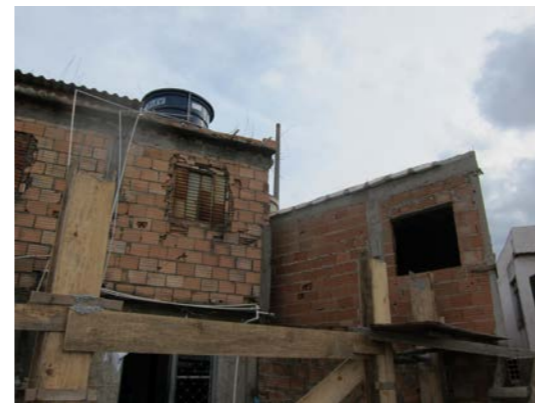
**LOUIS**

1	1978	Arrival. Family lives by rent
2	1990	Purchase of a house in another plot
3	1998	Purchase of the current plot, starts and finishes
4	2013	Initiate the construction of a new kitchen outside and a new bedroom and toilet on the second floor

2004				To buy an apartment in the formal city.			
	2009							
Louis	born there		-	In 1998 the family bought the piece of land and started building an embryo of what they have today - a bar on the street level; the family house on the underground floor, which will be increased to a second underground floor. They plan to rent the last as a housing unit.	To buy a car.	Since the house is located in the underground in relation to the street level, he believed the house should not have been built so close to the street limit, because of infiltration problems. In his opinion, he should have left an empty space of one meter wide to separate the building from the soil.	Y (He has started to build another dwelling and has owned a rented shop)	
	1978				To build a slab over the backyard, behind the house, and to expand the shop.			
	1978				To build a new kitchen outside, where they are building the roof and to use the current kitchen as a dining room.

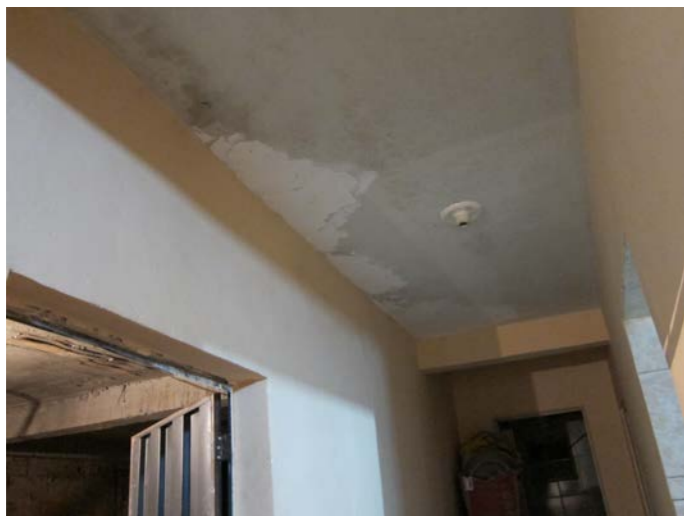
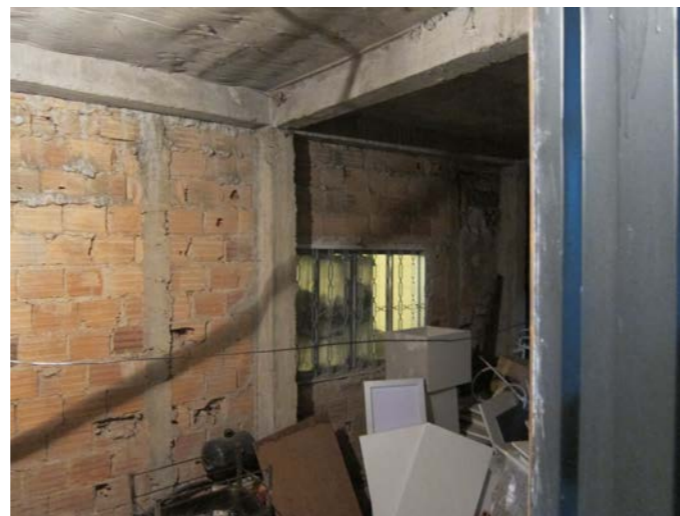
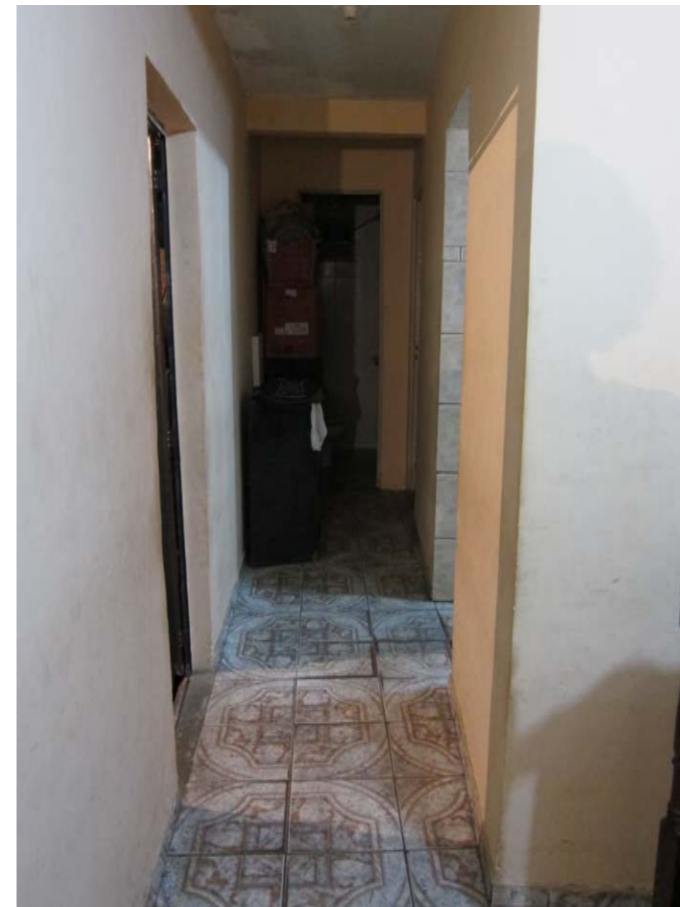
**NELY**

1	1986	Arrival, lives with siblings in another house
2	1992	Got married, lives with husband in another house
3	1998-2001	Purchase of land, construction of the house, purchase the land besides
4	2011	Start construction of garage besides
5	2013	Continues the construction of the garage

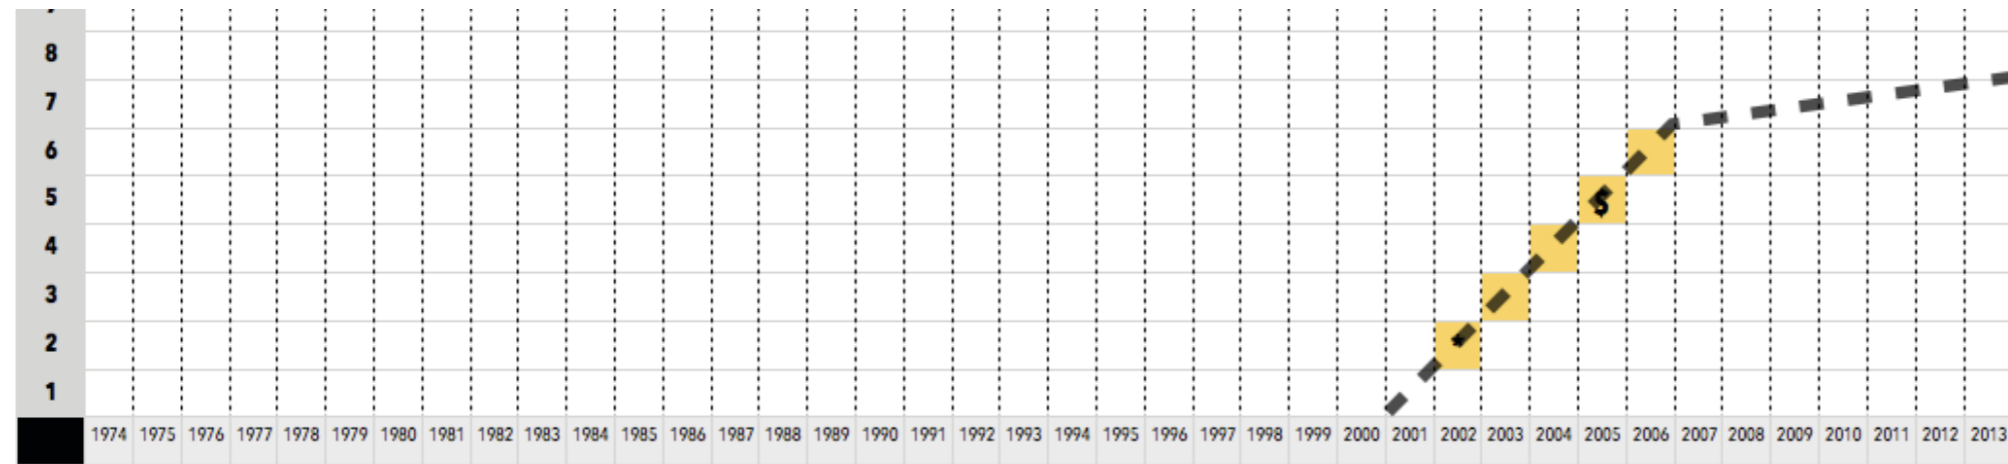
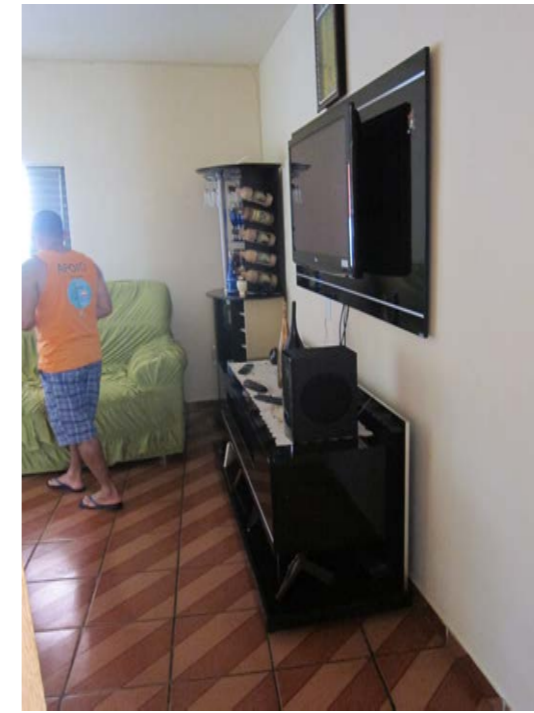
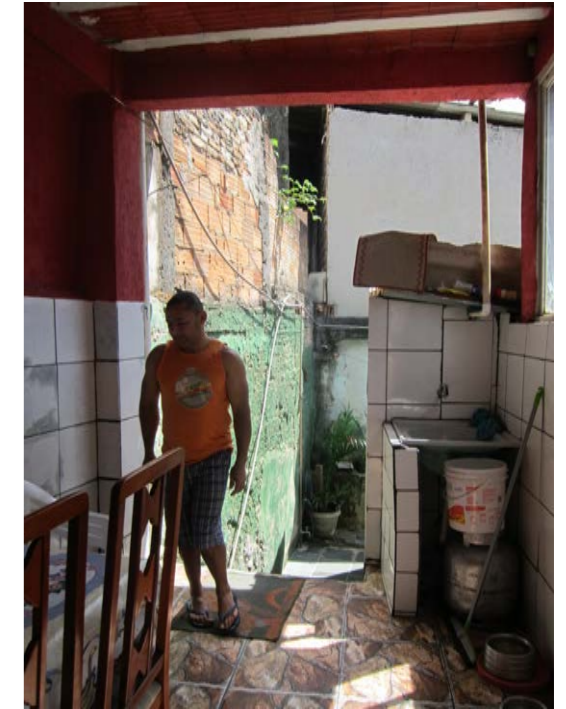
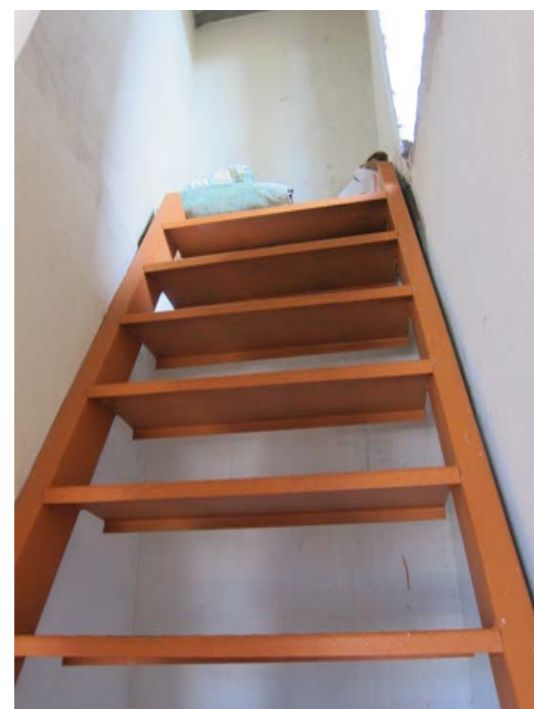
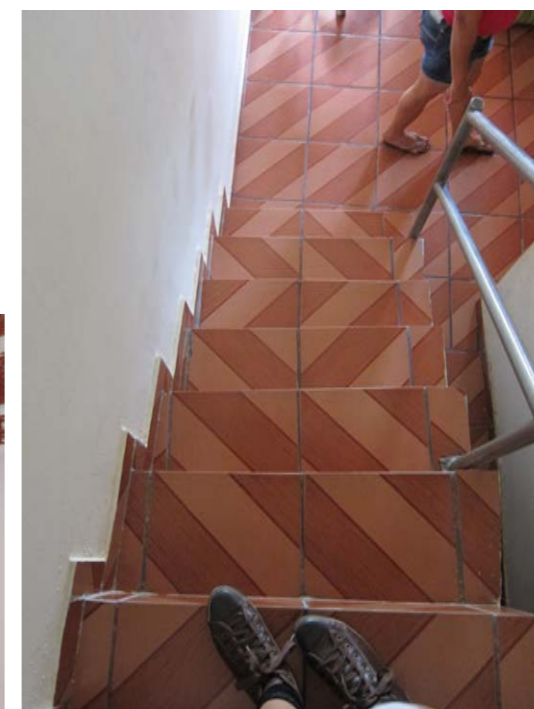
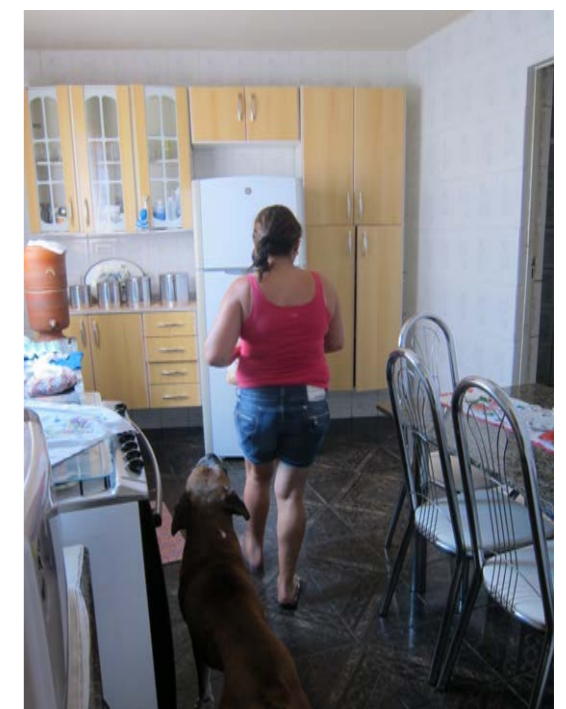
**CARLOTA**

1	2001	Construction of wooden hut - two rooms and one bathroom
2	2002	Purchase of land, start the construction of the ground floor - living room, kitchen and bathroom, without finishings or windows
3	2005	Assembling of brick slab in the second floor, construction of walls with apertures, but no windows
4		Finishings, tiles and plaster on the ground floor (veranda)
5		Purchase and installation of metallic stairs connecting the upper floor to the rooftop
6		Construction of laundry on the rooftop, with concrete structure, asbestos roof and a tank

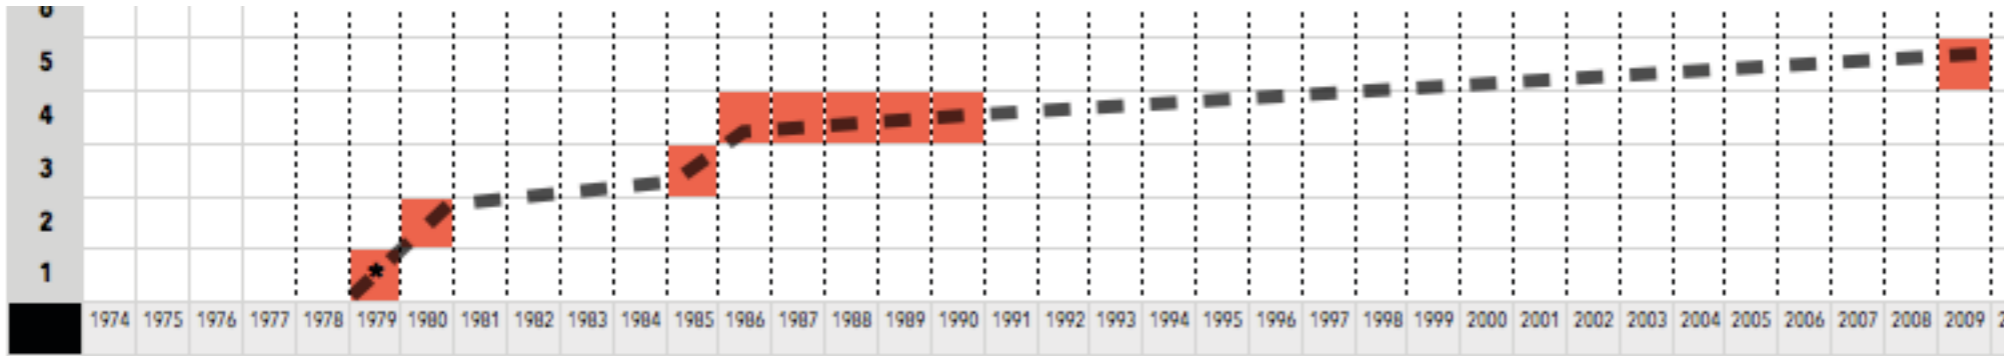
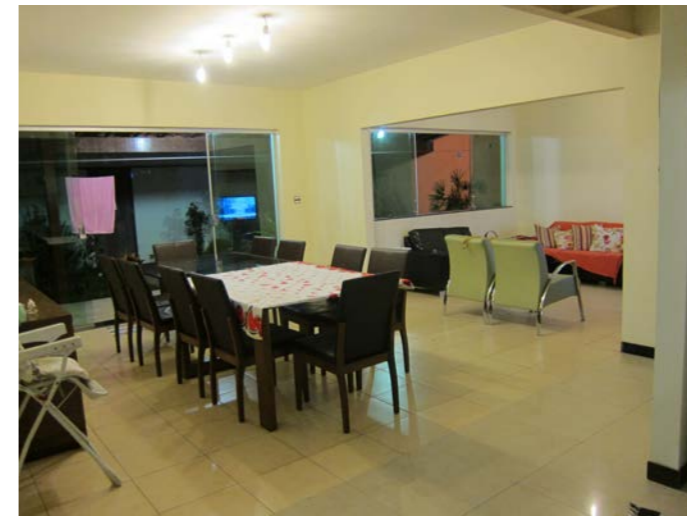
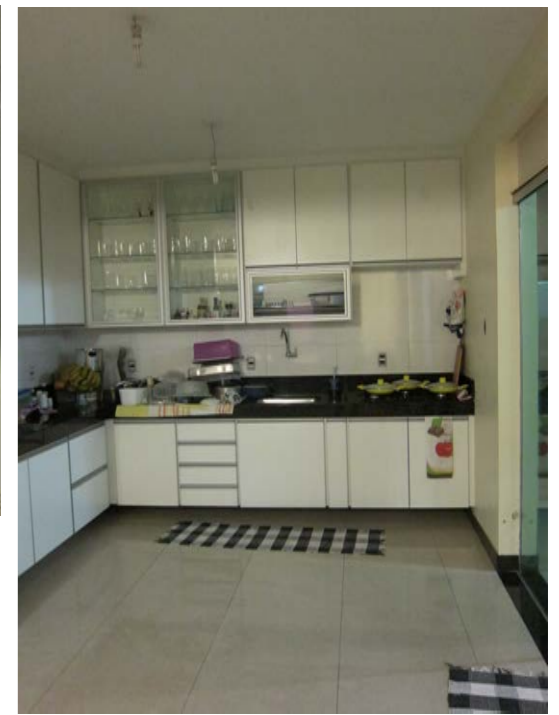
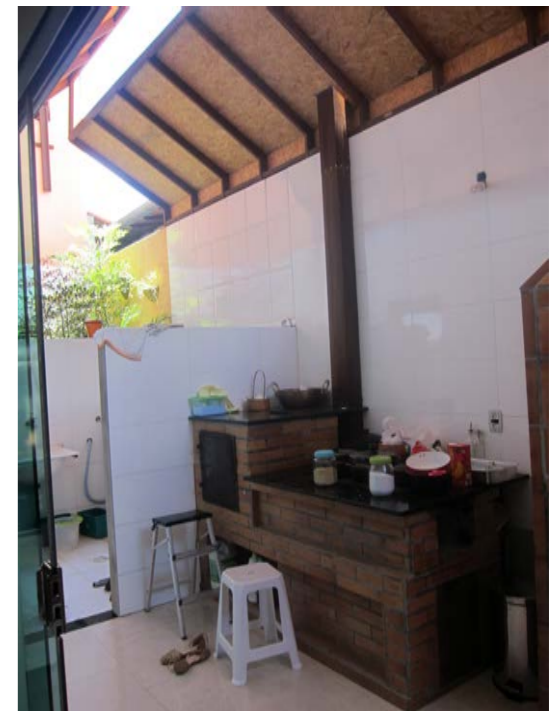
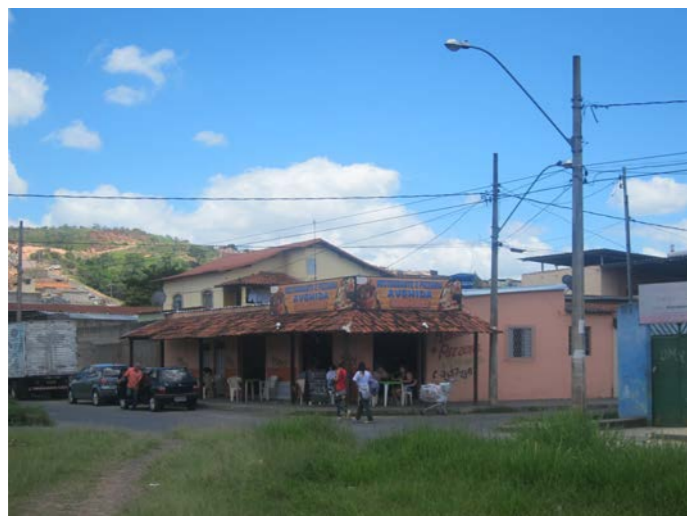
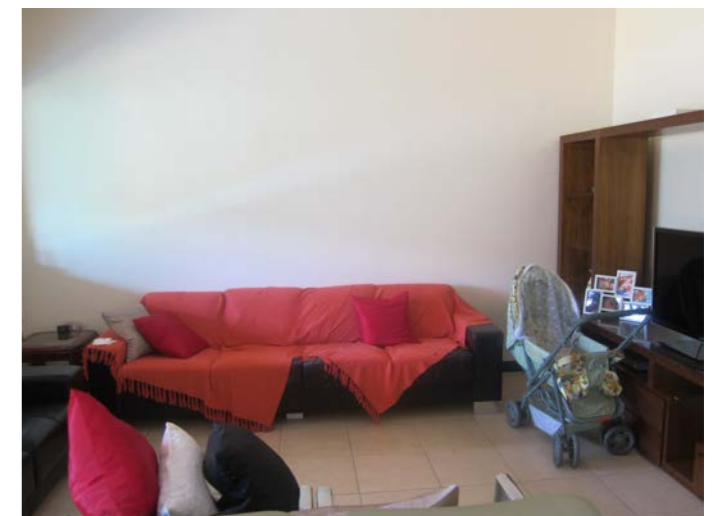
**OLIVER**

1	1979	Purchased of land
2	1980	Self-building of three rooms, initial embryo
3	1982	Moved in, but left in 1983.
4	1985	Construction of workshop in the back part of the plot.
5	1986-1990	Restarted the construction of the rest of the house
6	1990	Family moved back
7	2008-2009	Renovation of the house, construction of laundry and new bathroom.

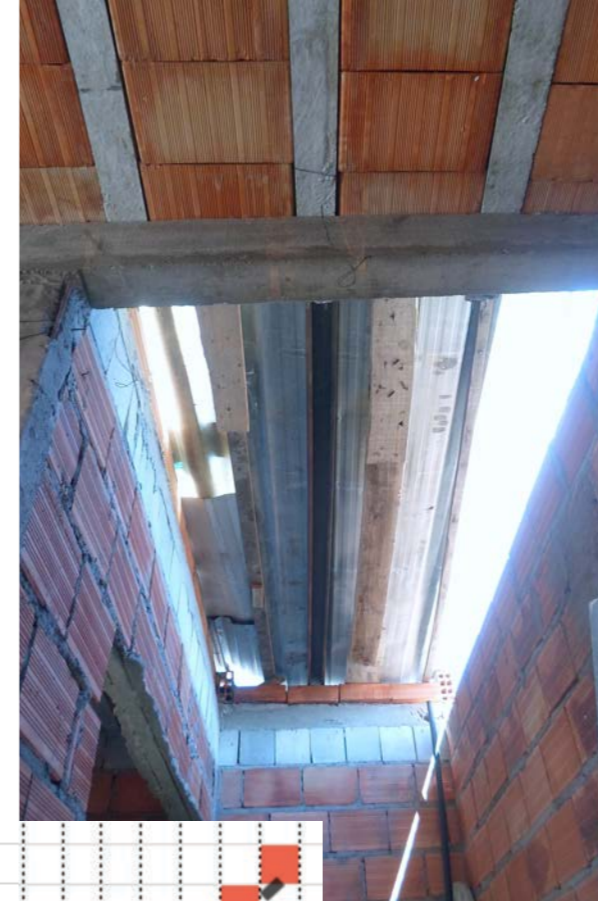
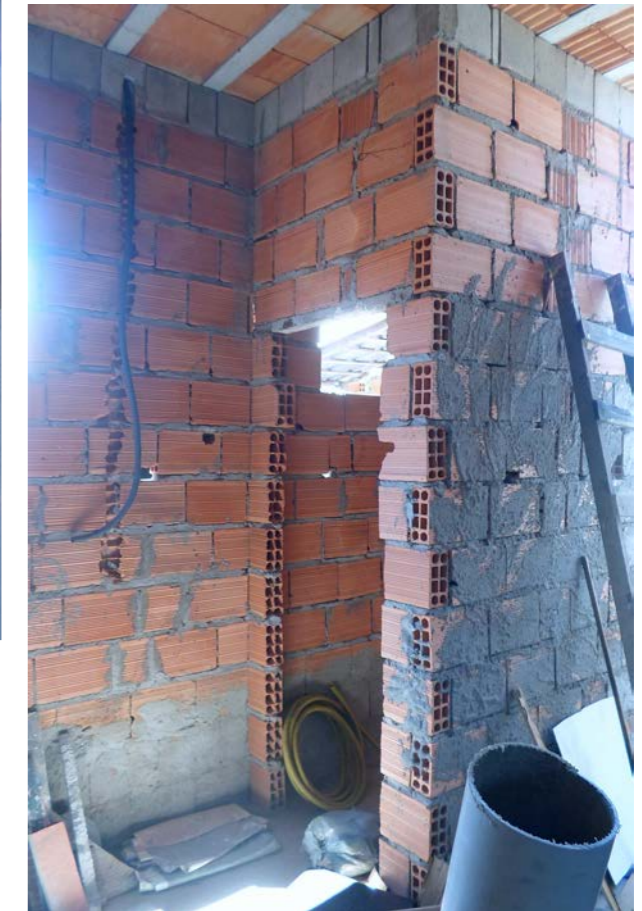
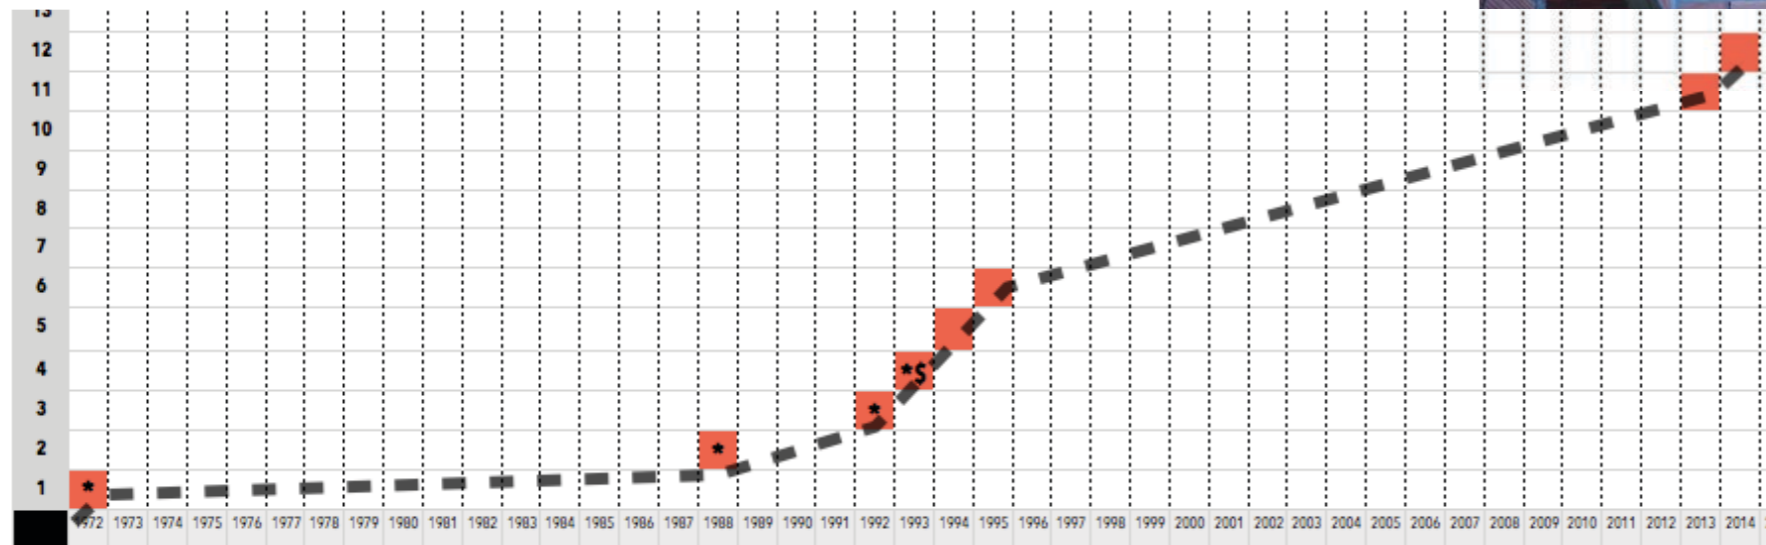
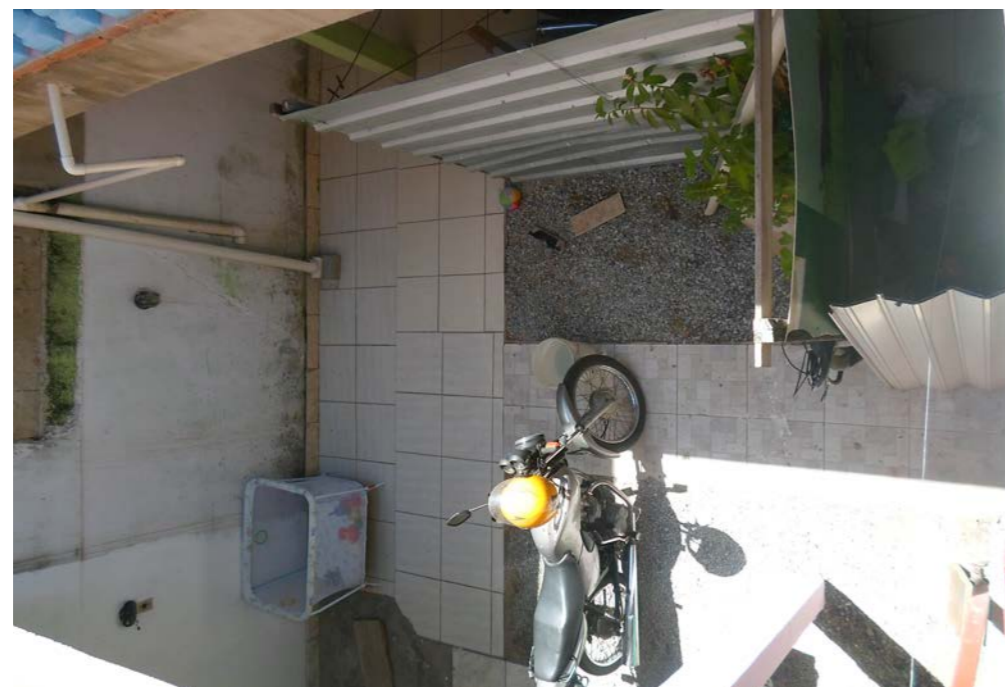
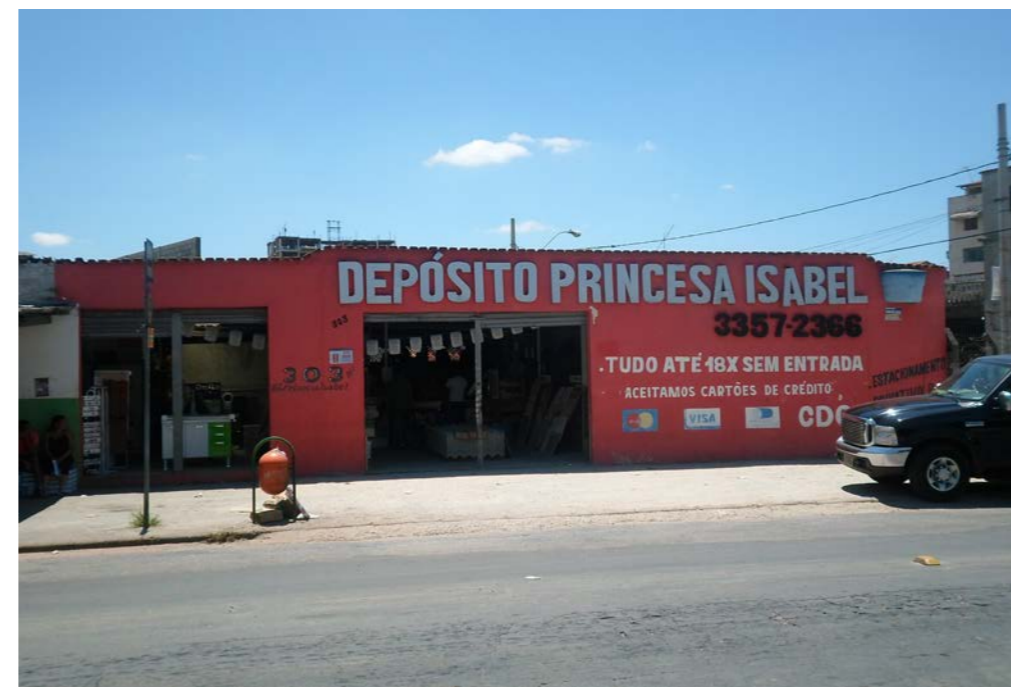
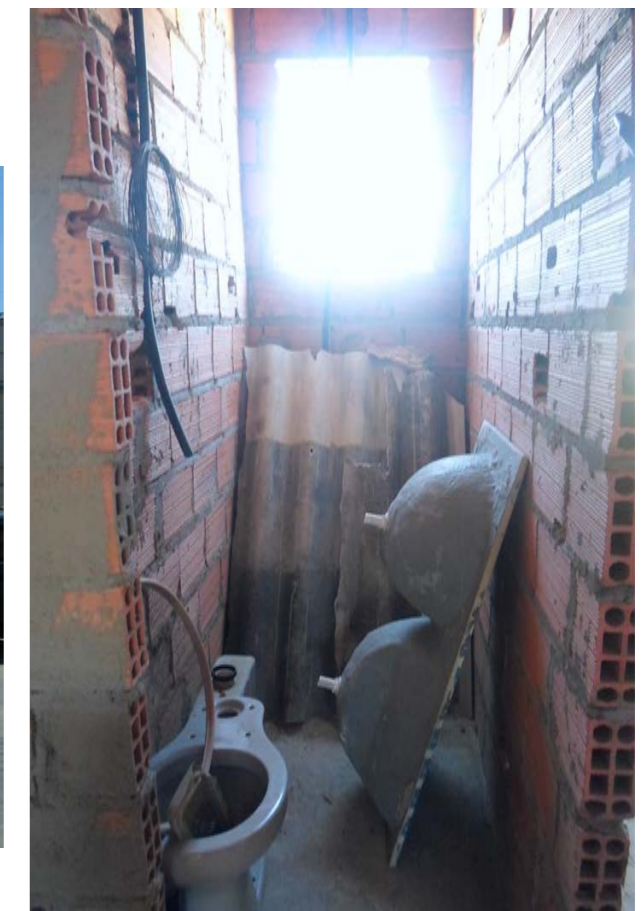
**EDUARDO**

1	1993	Purchase half-plot
2	1993-1994	Construction of a ground floor (2 bedrooms, living room, toilet and kitchen) - walls, slabs, windows, front door.
3	1994-1995	Finishings and facing in the ground floor (tiles, painting, doors)
4		Construction of two rooms upstairs
5		Construction of garage and small shops in front
6	2013-?	Construction of rent house on the upper floor

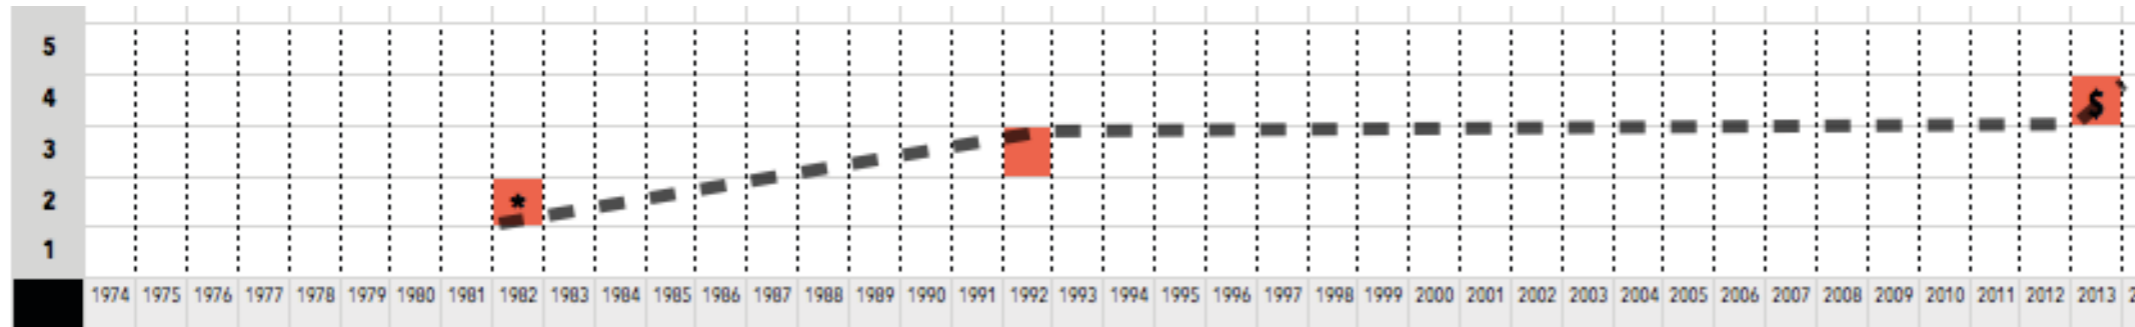
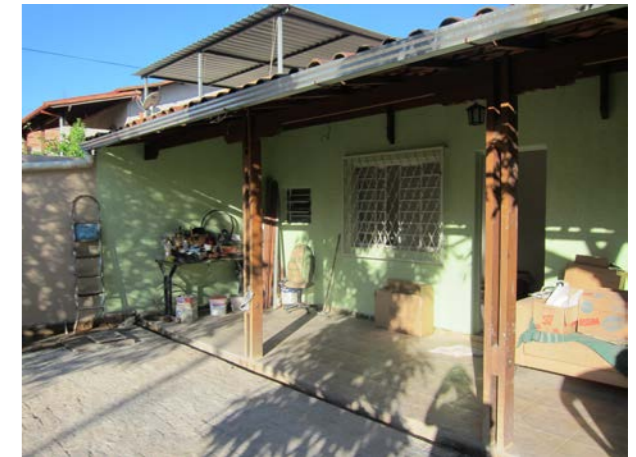
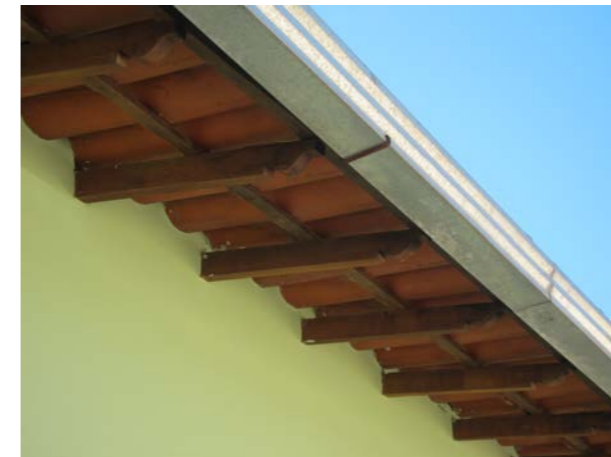
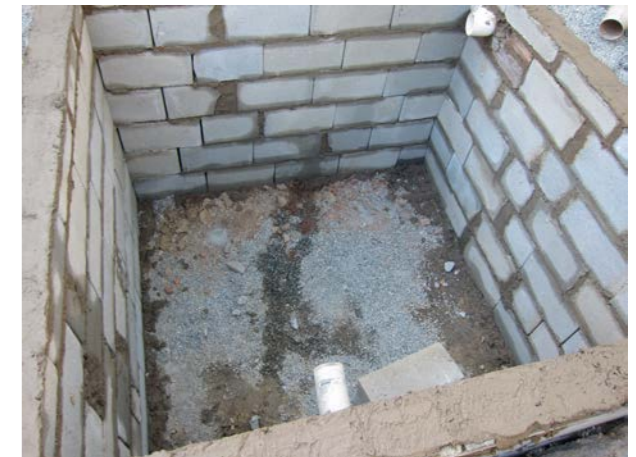
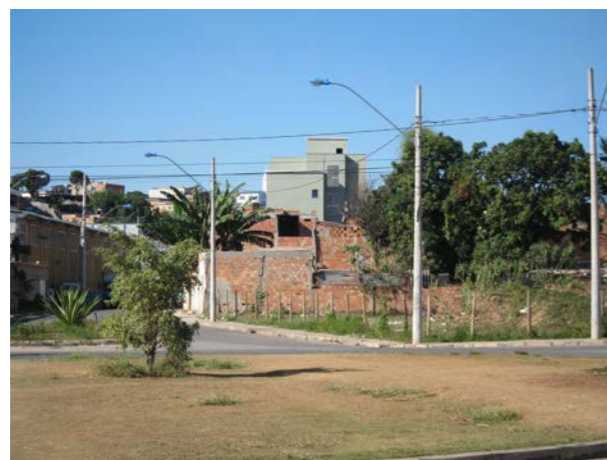
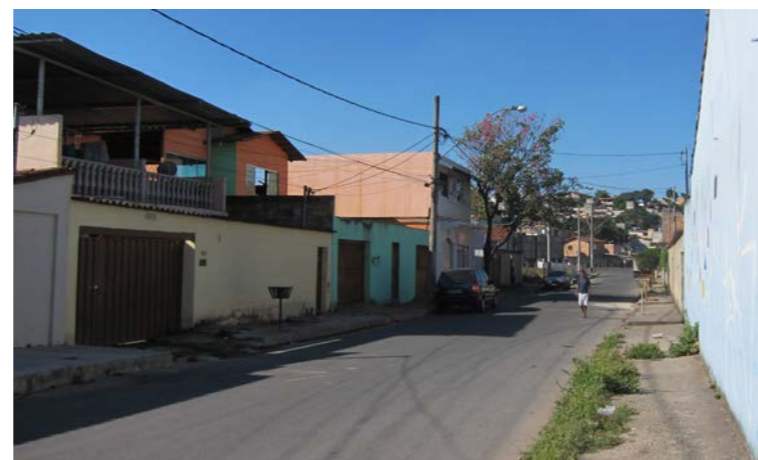
**RENATA**

1	1982	Arrival, purchase of house
2	1992	First renovation, change of tiles and painting
3	2013	Second renovation - change of finishings, assembling of classroom, roof, drainage

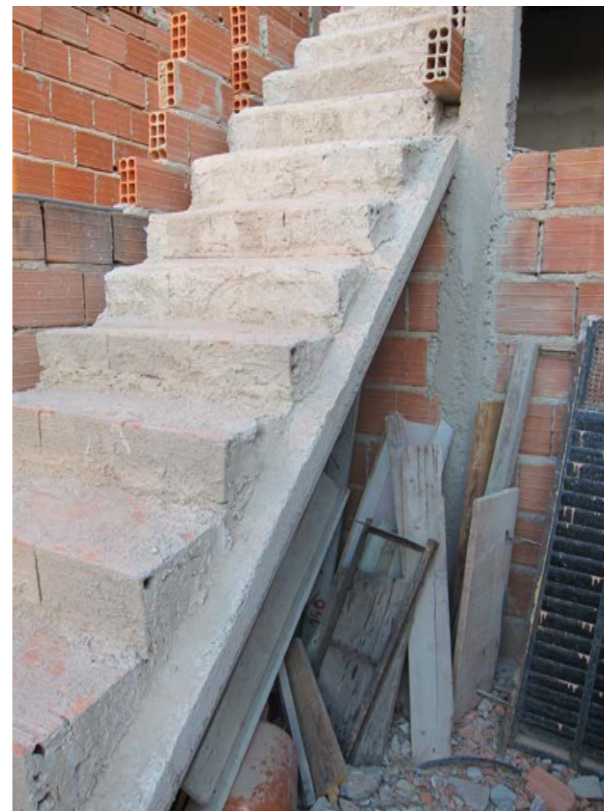
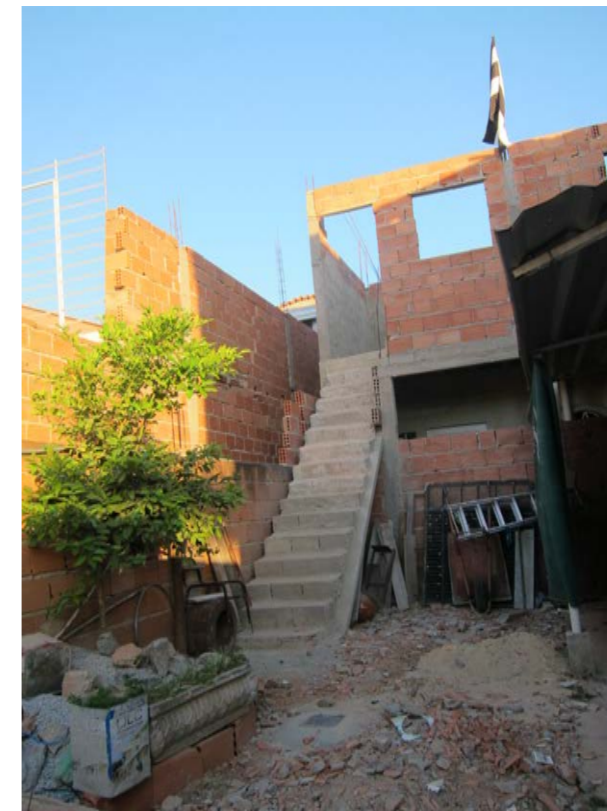
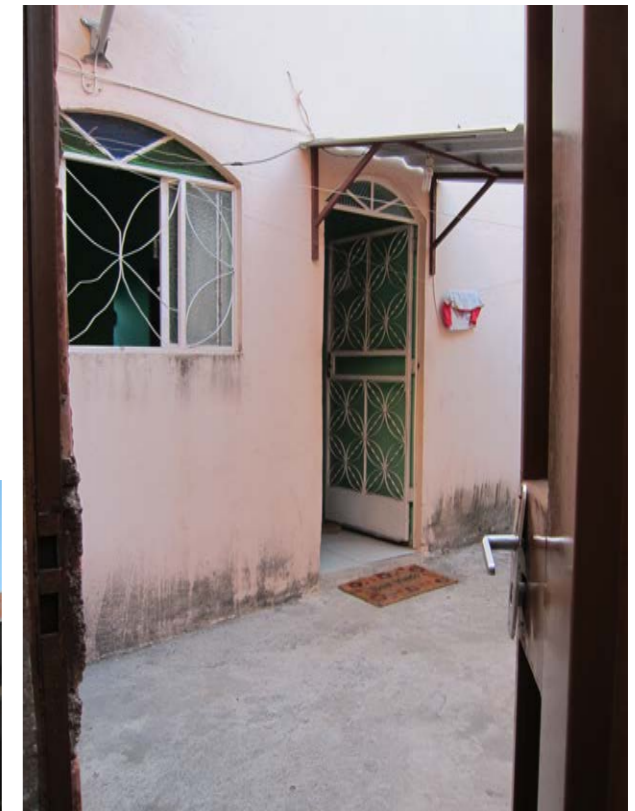
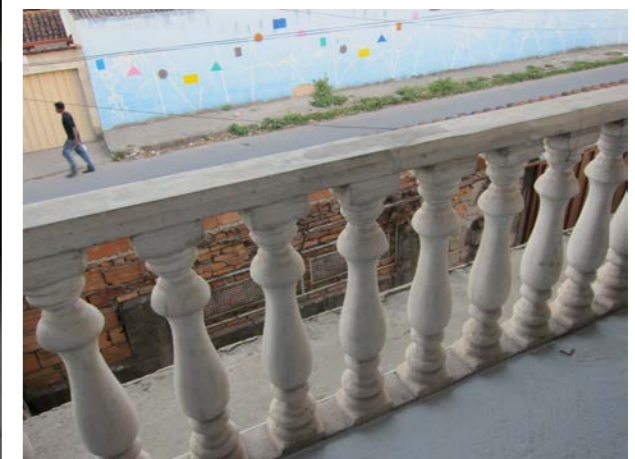
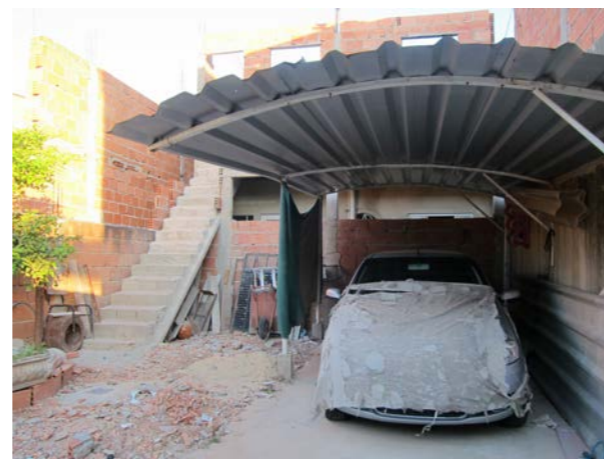
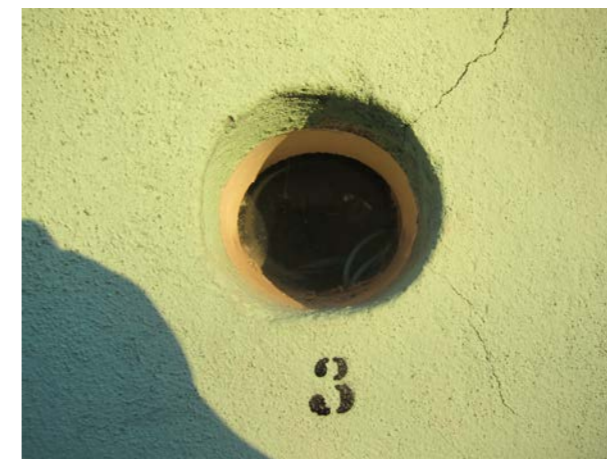
**João**

1	1985	Construction of hut in mother's plot
2	1985-1992	Construction of family house on the second floor of mother-in-law's house
3	2000	Purchase of half-plot
4	2002	Construction of first housing unit
5		Construction of second housing unit
6		Construction of third housing unit
7	2013	Construction fourth housing unit

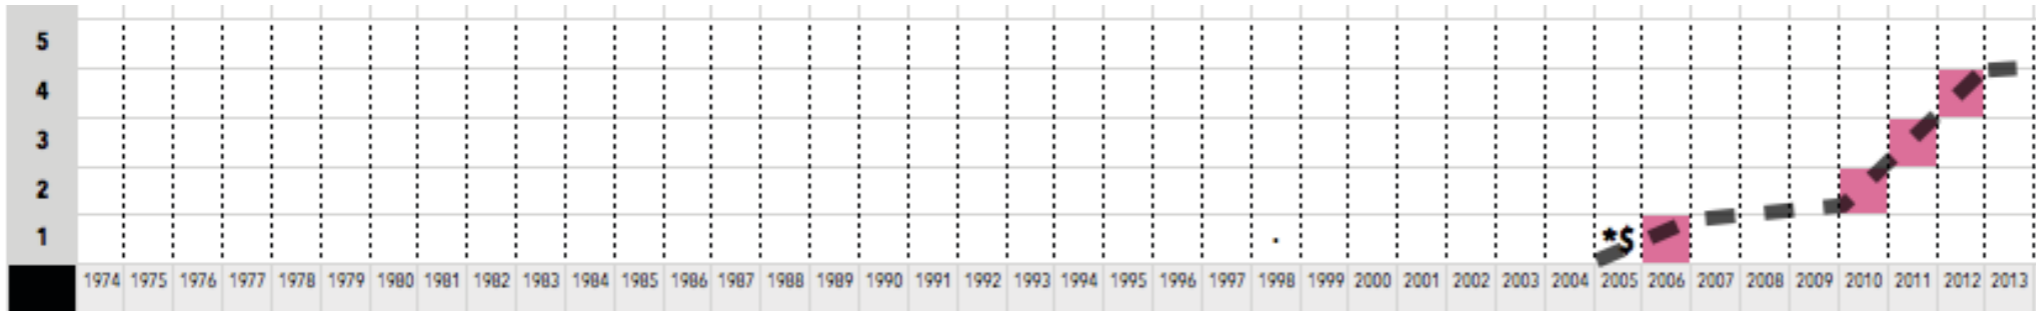
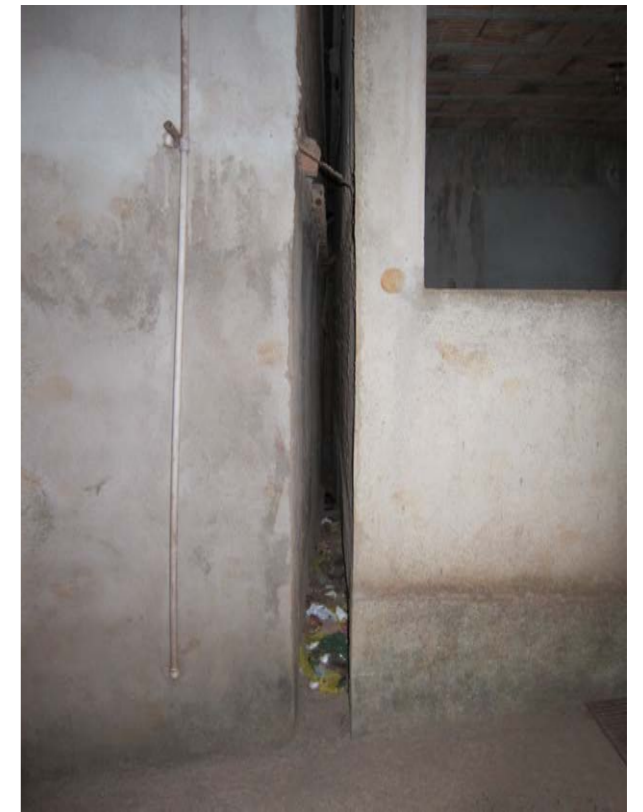
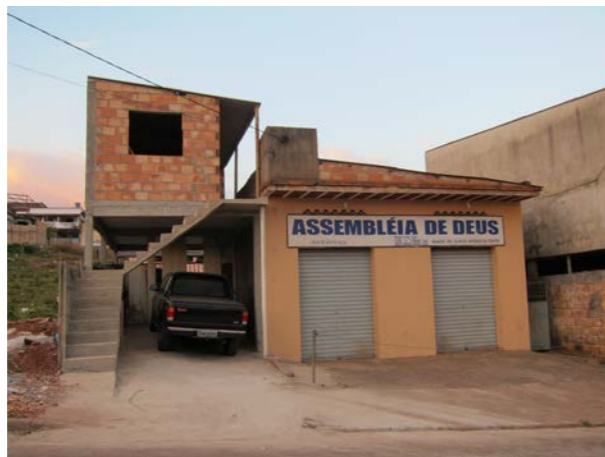
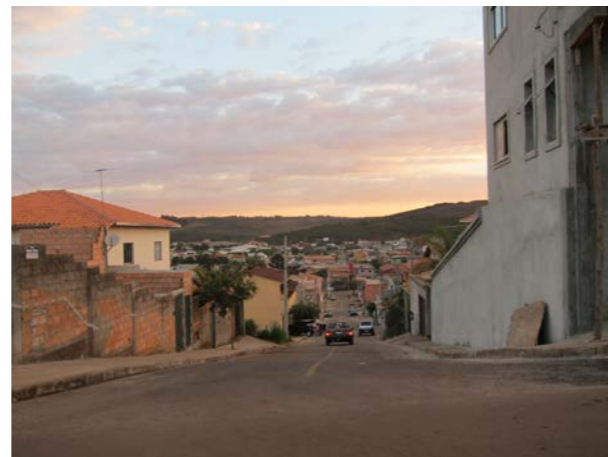
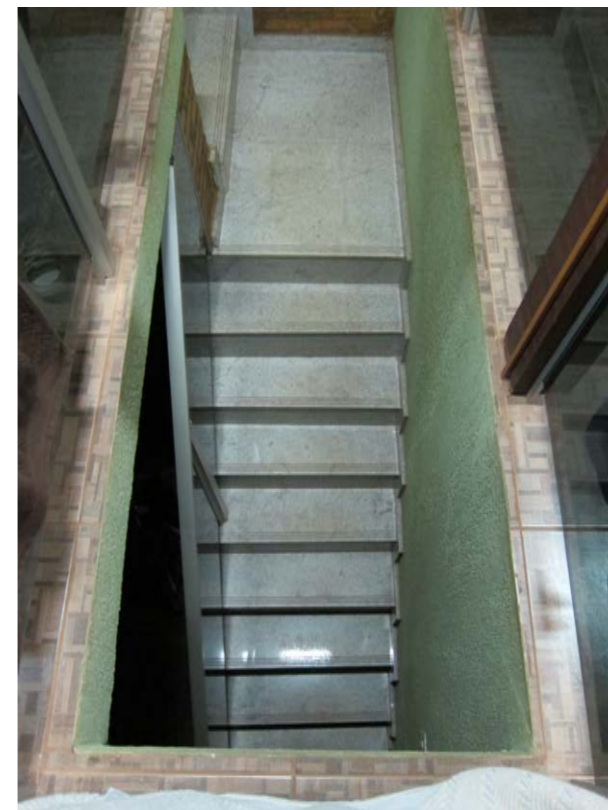
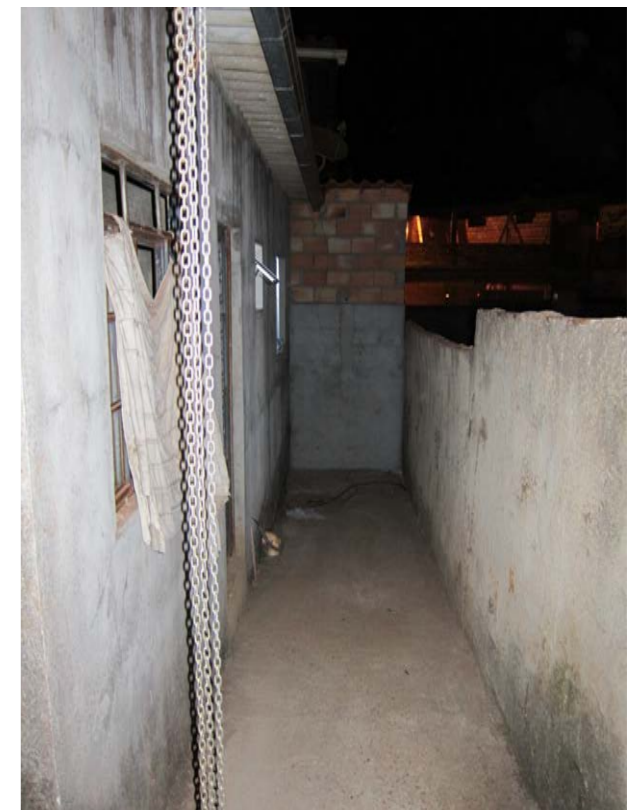
**HUGO**

1	2005	Purchase of plot, start building
2	2005	Construction of ground floor - two rooms, living room, kitchen and toilet (without finishings)
3	2010-2012	Construction of upper floor - two rooms, living room, kitchen and toilet, with most finishings
