APPENDIX  
QUICK GUIDE TO CASE STUDIES

**CASE STUDY'S TIMELINES - PHOTOS FROM DWELLINGS AND THE FROM LOCAL URBAN ENVIRONMENT<sup>12</sup>**

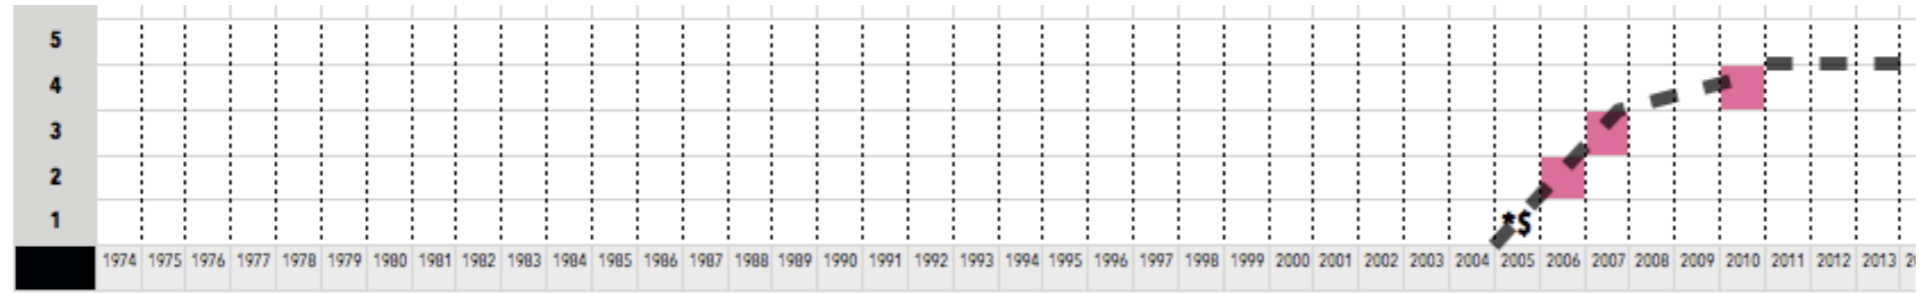
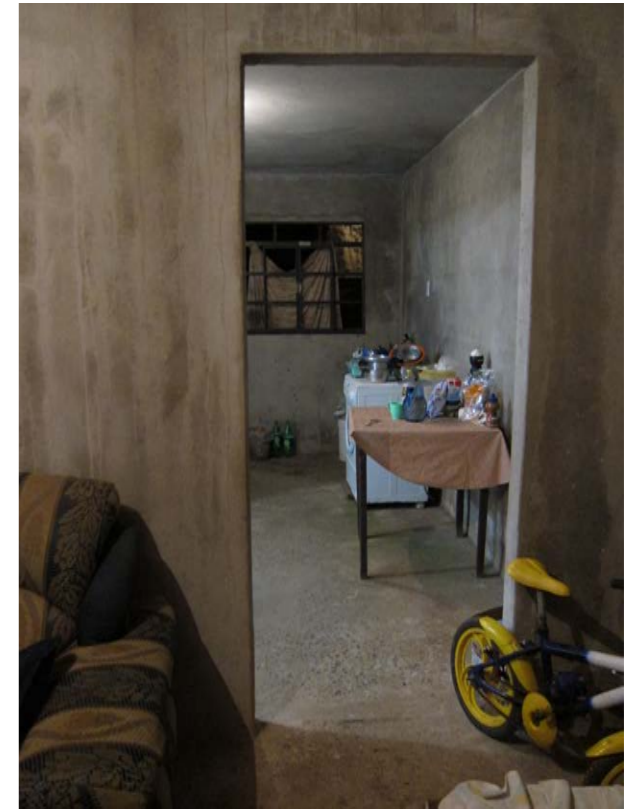
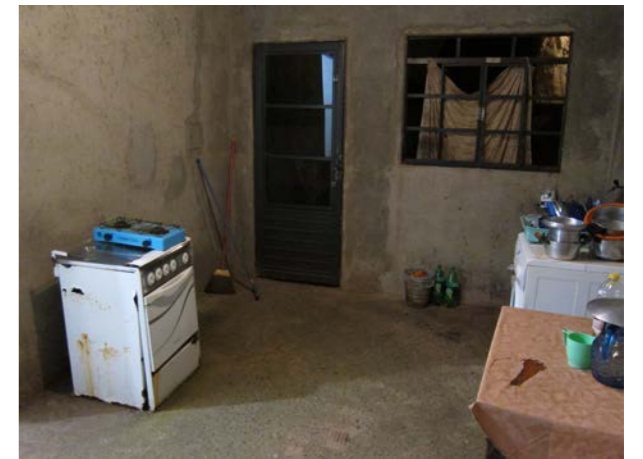
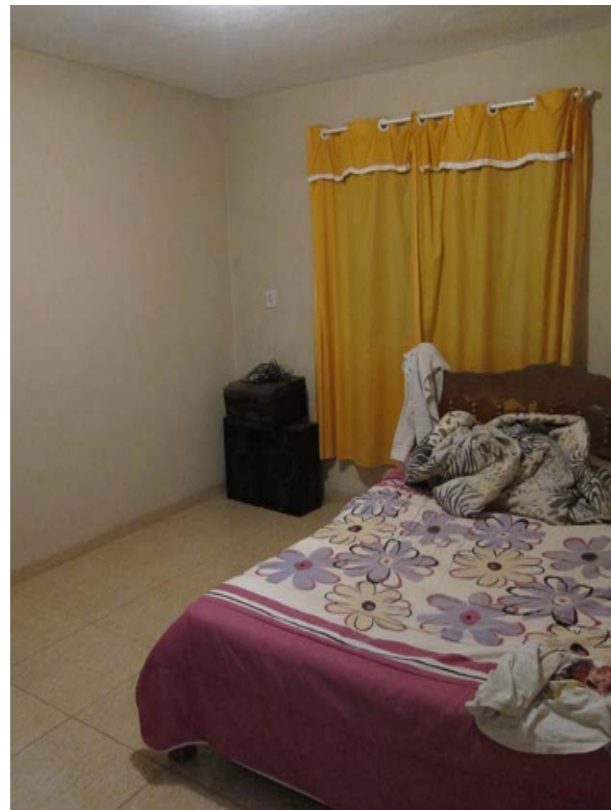
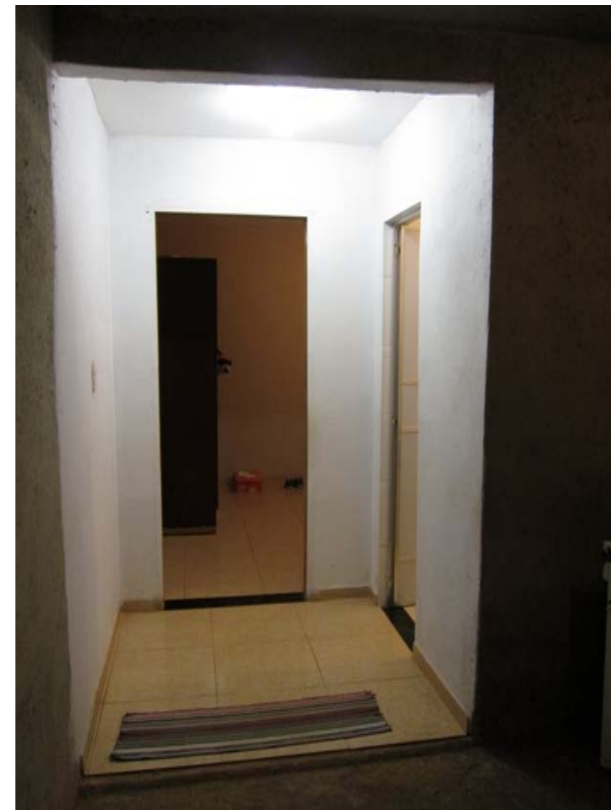
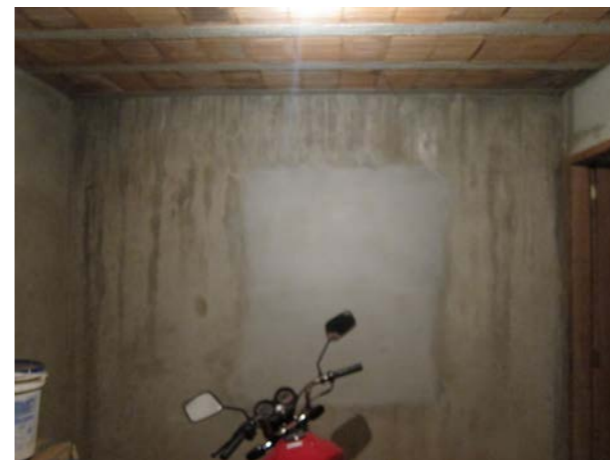
**CARLOS**

1	2005	Purchase of plot
2	2006	Construction of two rooms and toilet, plastered without painting
3	2008-2010	Improvement, construction of entrance hall and kitchen, plastered without painting
4	2013	Internal changes and kitchen ?

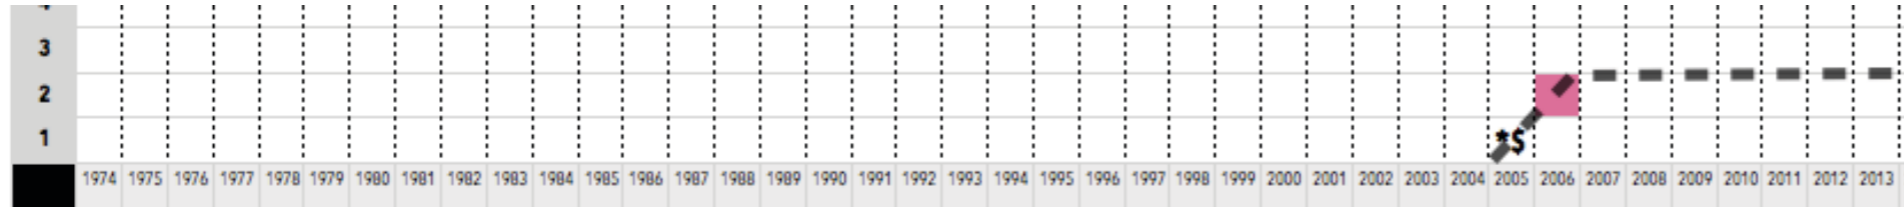
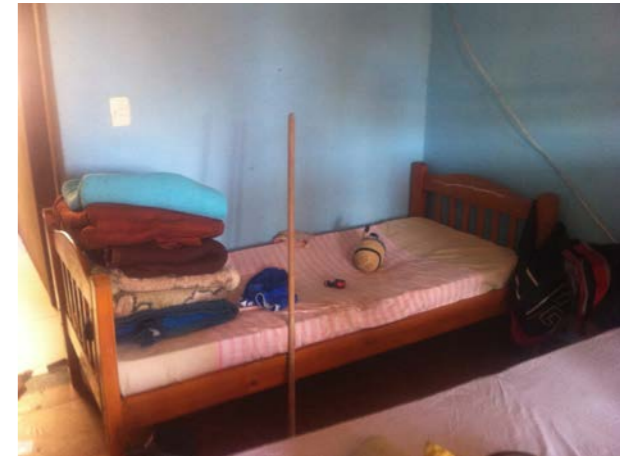
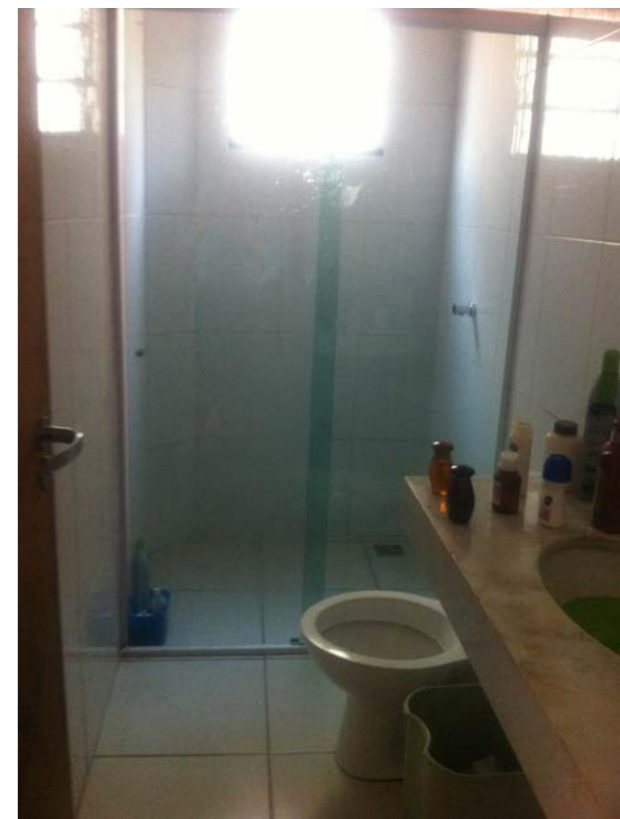
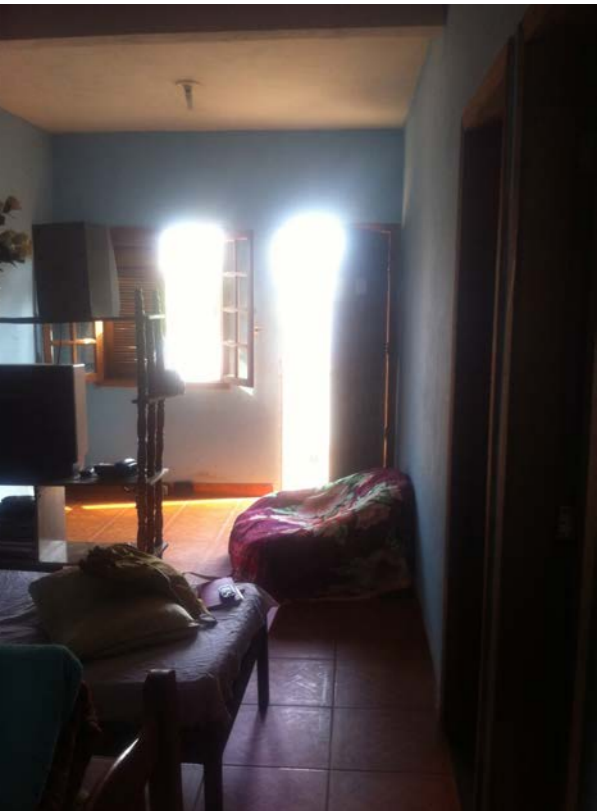
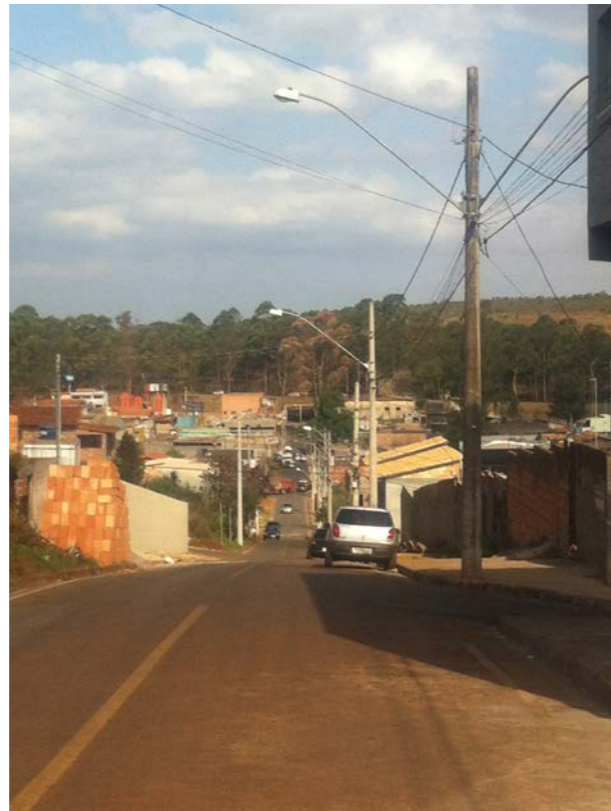
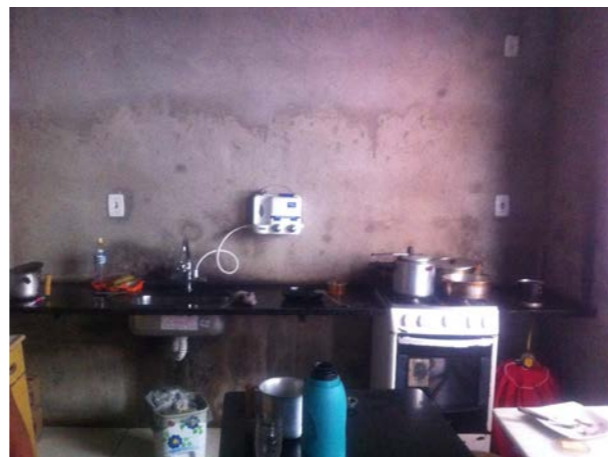
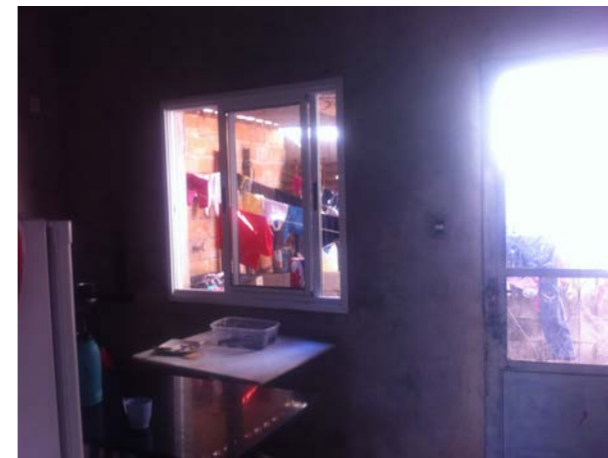
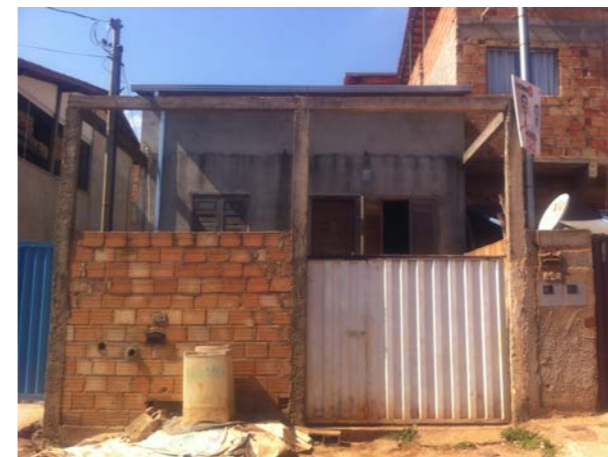
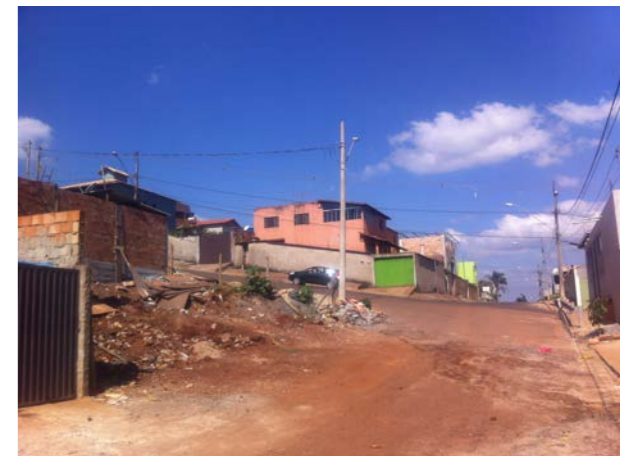
**Rosa**

1	2006	Purchase of plot
2	2007	Construction of all the house at once, without tiles but with painting
