Annex 5

A5-3 Documentation of damage cases

Table A5-3.1	Sultandağı, residential building	(SUL)
Table A5-3.2	İzmit, residential building	(IZT-1)
Table A5-3.3	İzmit, residential building	(IZT-2a)
Table A5-3.4	İzmit, residential building	(IZT-2b)
Table A5-3.5	İzmit, residential building	(IZT-2c)
Table A5-3.6	Düzce, residential building	(DUZ-1)
Table A5-3.7	Düzce, residential building	(DUZ-2)
Table A5-3.8	Seymen, residential building	(SEM)
Table A5-3.9	Sapanca, residential building	(SAC)
Table A5-3.10	Gölyaka, Yavuzlar Fındık	(YZL)
Table A5-3.11	Cumaná, Avenida Perimetral	(AVE)
Table A5-3.12	Cumaná, Edificio Miramar	(MIR)
Table A5-3.13	Cumaná, Edificio Residencial	(EDR)
Table A5-3.14	Cumaná, Edificio de oficinas Toyota	(TOY)

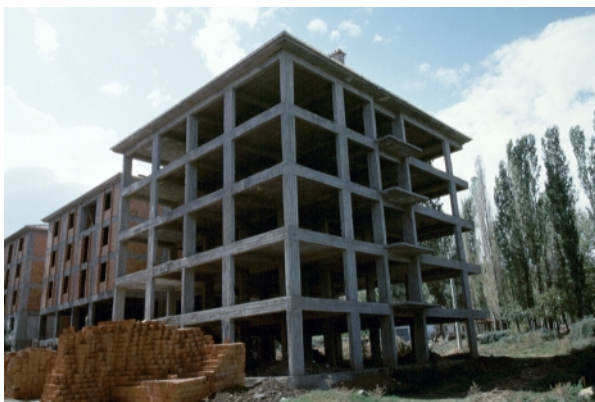
General view of the northwest facade

Year of construction:	2001/02	Elevation design:	regular
Anti-seismic design:	no	Plan design:	regular
Type of use:	residential building	Type of foundation:	RC strip foundation
No. of stories:	5	Type of slabs:	reinforced-concrete ($t = 0.12$ m)
Basement:	0	Type of infills:	no
Cores:	0	Grade of damage:	DG (EMS-98) = 3

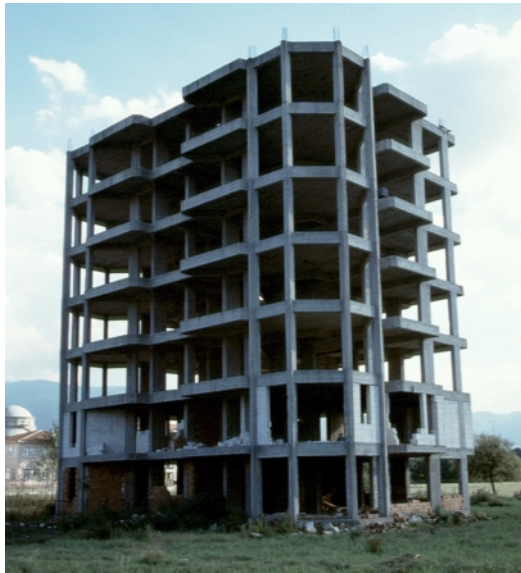
General view of the northwest facade

Year of construction:	1999	Elevation design:	irregular (partly brick infills in 1 st /2 nd story)
Anti-seismic design:	no	Plan design:	regular
Type of use:	residential building	Type of foundation:	RC plate-strip foundation
No. of stories:	7	Type of slabs:	reinforced-concrete ($t = 0.12$ m)
Basement:	0	Type of infills:	red bricks, cellular concrete
Cores:	1 (elevator shaft)	Grade of damage:	DG (EMS-98) = 3

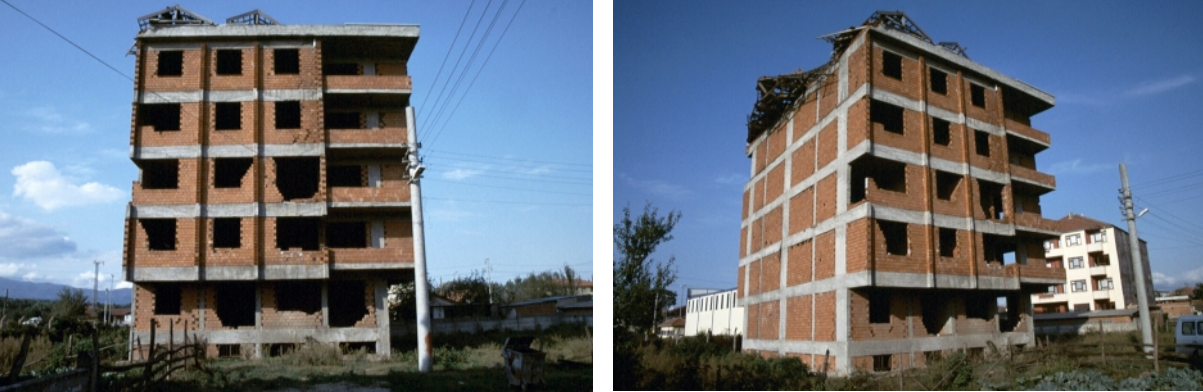
General view of the south facade		General view of the south-west facade

Floor plan (arrangement of columns and beams)		Schematic cross-section (story heights)
<i>Extent of structural damage</i>		
<ul style="list-style-type: none"> - very few small cracks to structural elements - moderate to heavy damage to nonstructural infill walls at every story - collapsed roof consisting of timber trusses and red tiles

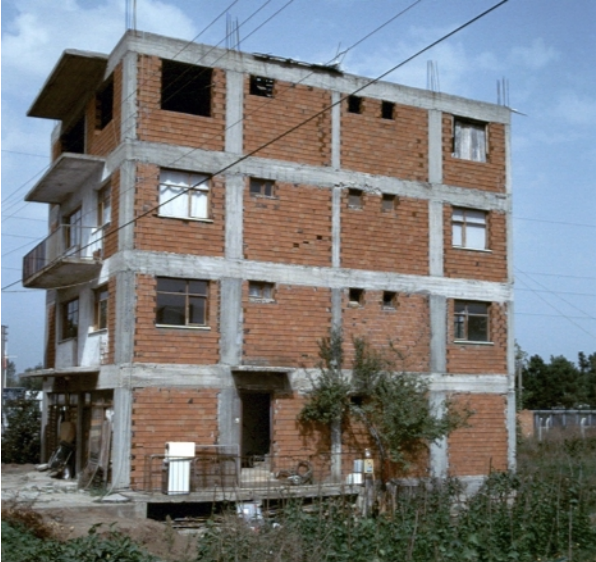
<p data-bbox="347 1323 703 1352">General view of the south facade</p> </div> <div data-bbox="842 734 1406 1294">

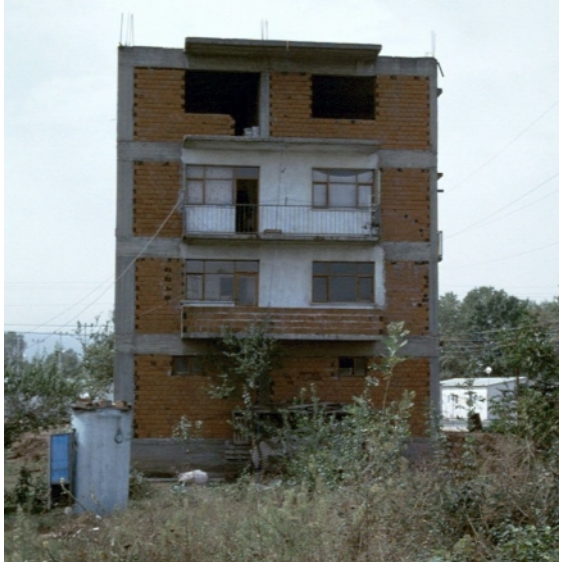
<p data-bbox="975 1323 1315 1352">General view of the east facade</p> </div> </div> <div style="display: flex; justify-content: space-around; margin-top: 20px;"> <div data-bbox="272 1375 783 1794">

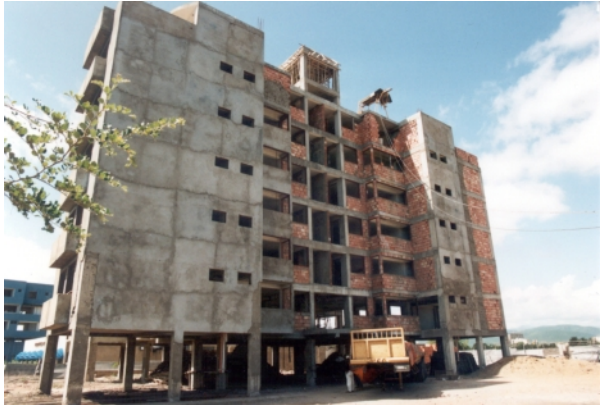
General view of the north facade

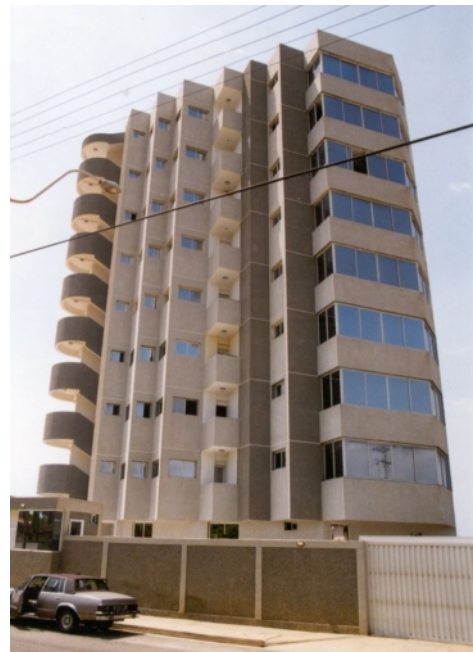
General view of the south facade
